Iowa City Heads Off Outfall Failure

Council Bluffs moves to head off a calamity at one of its largest sewer outfall lines, which carries about two-thirds of the city's wastewater

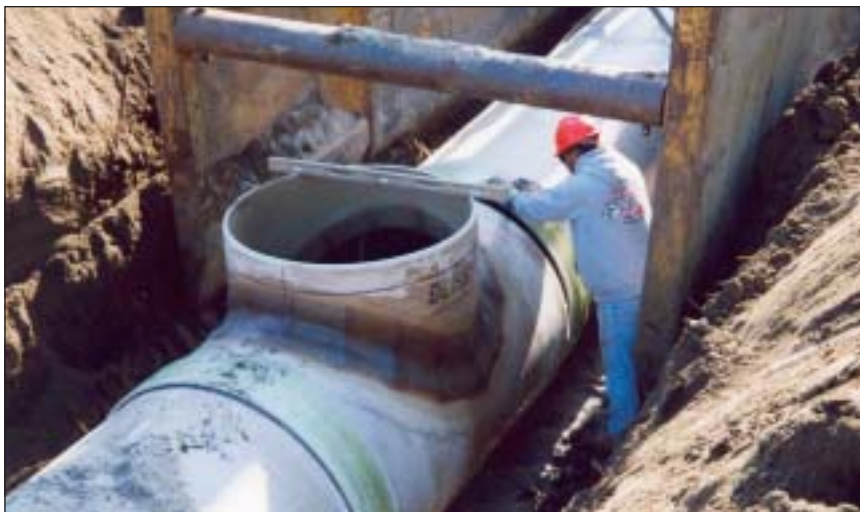
At stake was one of the city's largest sewer outfall lines, a 48-in. and 42-in. line that carried about two-thirds of the city's wastewater. The pipe was cracked, had off-set joints, and was corroding away from the inside. In some places the six-in. wall thickness had deteriorated to only a couple of inches.

The walls of one of the city's largest sewer outfall lines had corroded from six in. thick to only a few inches. Placement of the new pipe brought city engineers much needed relief from fear of a catastrophic failure.

After careful analysis, the city opted to conduct a series of five projects to replace the old sewer with a new 60-in. line made with HOBAS pipe. The cost of each project ranged from \$780,000 to \$2.6 million. In total, the city now has almost 17,000 linear ft of new sewer line ranging from 42 to 60 in. in diameter, much of it parallel to the old sewer but in a more efficient layout and designed to accommodate future growth.
