A Baton Rouge Emergency

Sinkhole repair is complicated by above- and below-ground utilities.

By Jeff Duplantis and Philip R. Snyder

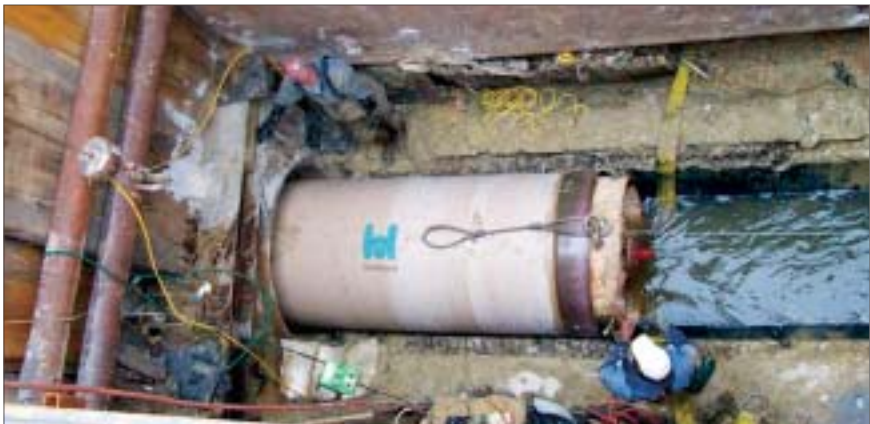
Allen & LeBlanc crew members slipline the 48-in. CCFRPM pipe into position. The integral fiberglass low profile bell is gasketed and provides a watertight seal with the spigot joint while allowing the pipe to be pulled or jacked into the host pipe. The low profile design prevents hang-ups and minimizes friction during installation. The entire project was approximately 400 ft long.

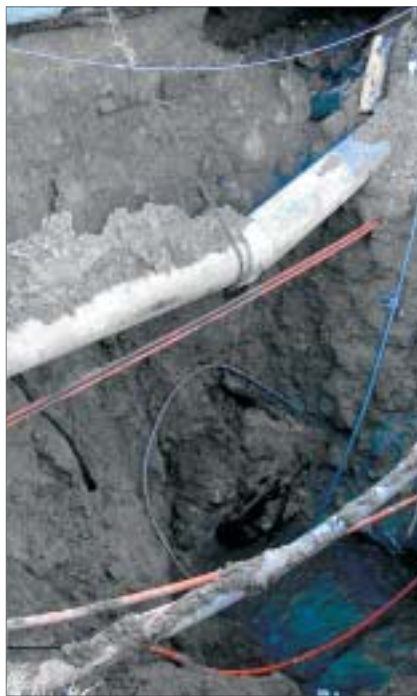
The Essen Lane collapse exposed the failure in the top of the 54-in. RCP sanitary sewer gravity main. At the top, a 15-in. potable water main is broken and numerous other utilities are adjacent, including telephone, cable, and fiber optic lines.

The existing sewer line was a 54-in. gravity sewer main. DPW's intent was to repair the failed section with fiberglass sliplining pipe installed between the upstream and downstream manholes. The lead times were too long for the several local fiberglass manufacturers and suppliers they had contacted. They had to find one that could provide the required pipe at a good price in a short time.

The plan was to use the CCFRPM pipe to slipline the failed sewer from the failure point, which was located just outside of the upstream manhole, to the downstream manhole where quality connections could be made to the existing system.

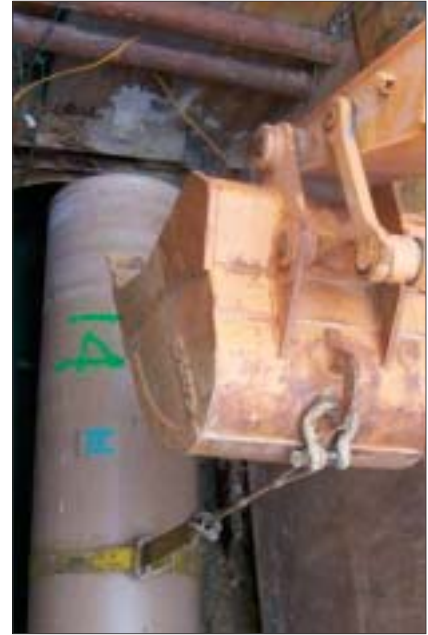
A sling attached to an excavator easily handled a lightweight 20-ft joint of 48-in. CCFRPM sliplining pipe, lowering it into the installation pit.

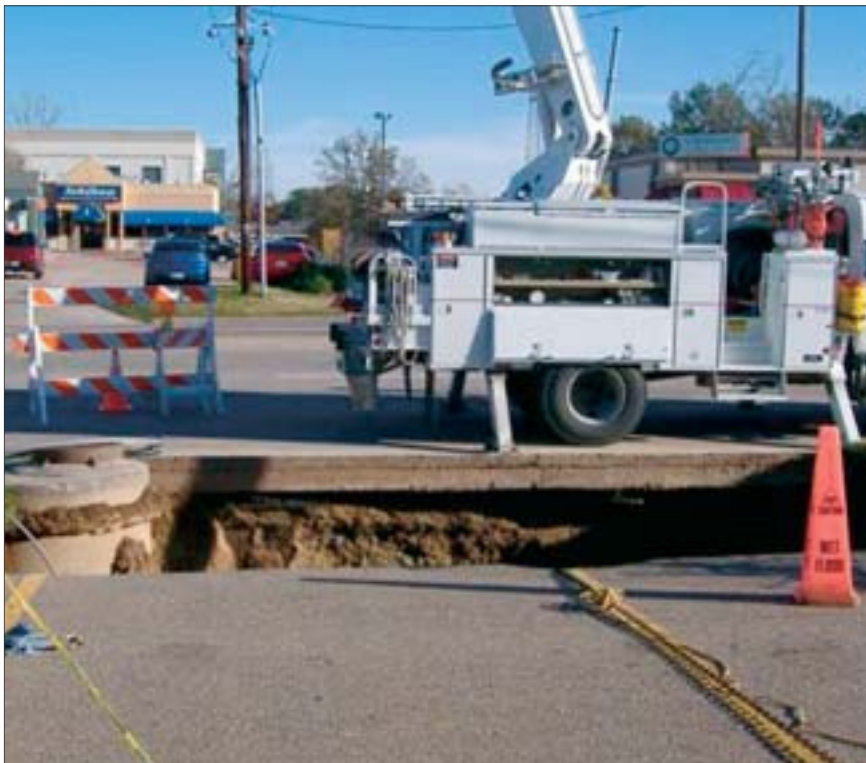
A sinkhole formed in Baton Rouge along the shoulder of Essen Lane, washing out of the area beneath the Albertson's parking lot. A nearby Entergy power pole and several buried utility lines were in danger.
