# Glass Reinforced Plastic Panels Rehabilitate Century Old Sewer

Fort Wayne, IN, faces the challenge and expense of maintaining an aging sewer system.

By Lynn E. Osborne

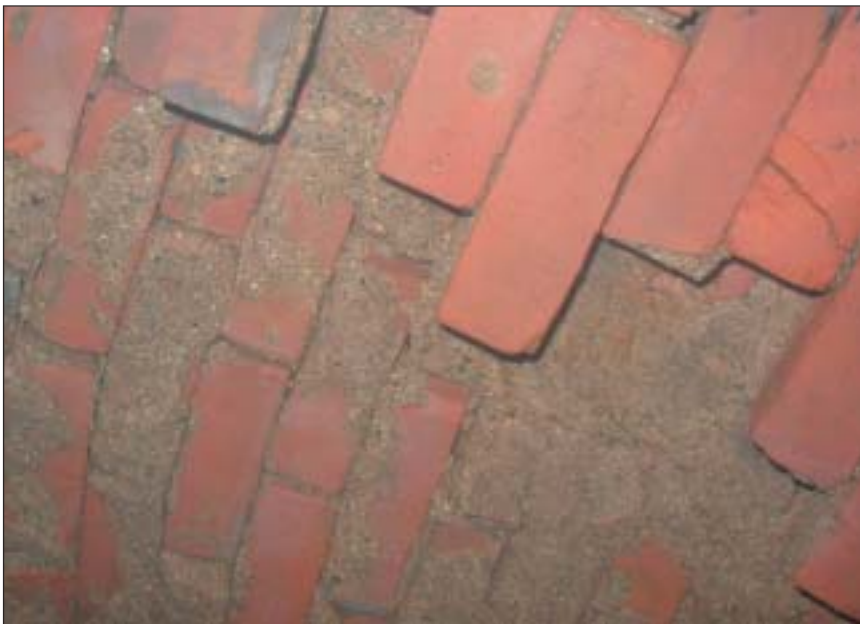
**T**he Taylor Street combined sewer is a 100-year old, 72-in. diameter, two-ring brick sewer. Located under a busy multiple-lane road, the sewer makes a 90-degree turn at the intersection of Taylor and Nelson Streets near downtown Fort Wayne. Although crown cracks are not uncommon in large-diameter brick sewers, an assessment found that this line exhibited crown cracks with significant vertical deflection. In addition to mortar loss and a severe diagonal crack in the 90-degree bend, the sewer also had a 4-ft by 5-ft section of bricks missing.

Engineers suspected that the diagonal cracking in the 90-degree bend was

caused by forces from the flow's thrust during heavy rainfall. The structural problems were believed to be caused by groundwater infiltration through the walls of the sewer. Cracks and permanent deformation are often a result of the loss of external support and uneven loading. Based on their assessment, engineers recommended rehabilitating about 140 ft of the sewer at two different locations.

*Mortar loss and severe diagonal cracking in the bend were compounded by a 4-ft by 5-ft section of missing blocks.*

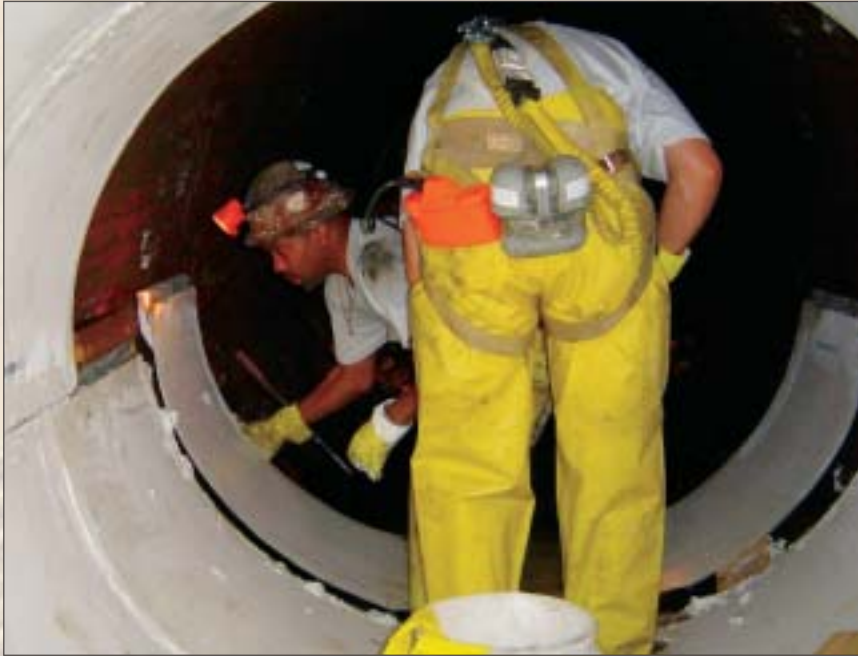
*After panels were lowered down the Nelson street shaft they were carried through the sewer and around the 90-degree bend to the designated location under Taylor Street where they were assembled.*

Only after the panel dimensions were determined were the panel molds constructed and manufacturing begun. During this time, Affholder excavated an eight-ft diameter shaft at a manhole on Nelson Street to the top of the sewer. Affholder installed the first set of panels in a 40-ft long section beneath Taylor Street. After cleaning the sewer, the construction crew lowered the panels down the Nelson Street shaft and then carried them through the sewer and around the 90-degree bend to the designated location under Taylor Street.

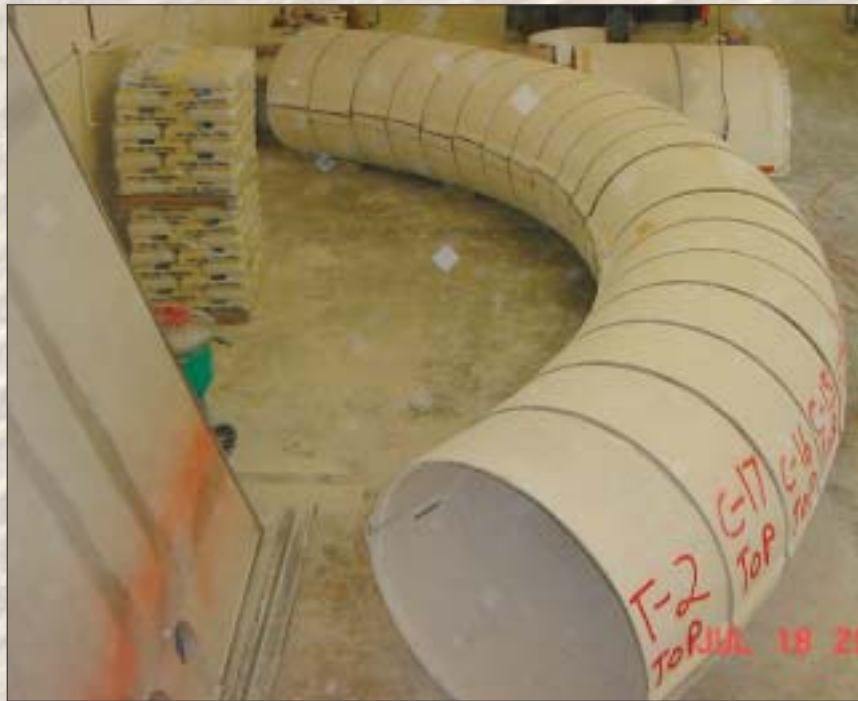
*This test assembly of the 90-degree bend was first done on the manufacturing plant floor to verify the proper alignment.*

Workers then addressed the second part of the rehabilitation project: a 100-ft section of pipe beneath Taylor Street and the Taylor Street/Nelson Street intersection. Seventeen trapezoidal-shaped panels had been custom manufactured that, when fitted together, formed a 90-degree bend. These panels had first been assembled on the manufacturing plant floor to verify the proper alignment. Each joint comprised five-degrees of the bend, which was 36-ft long and included two transition panels.

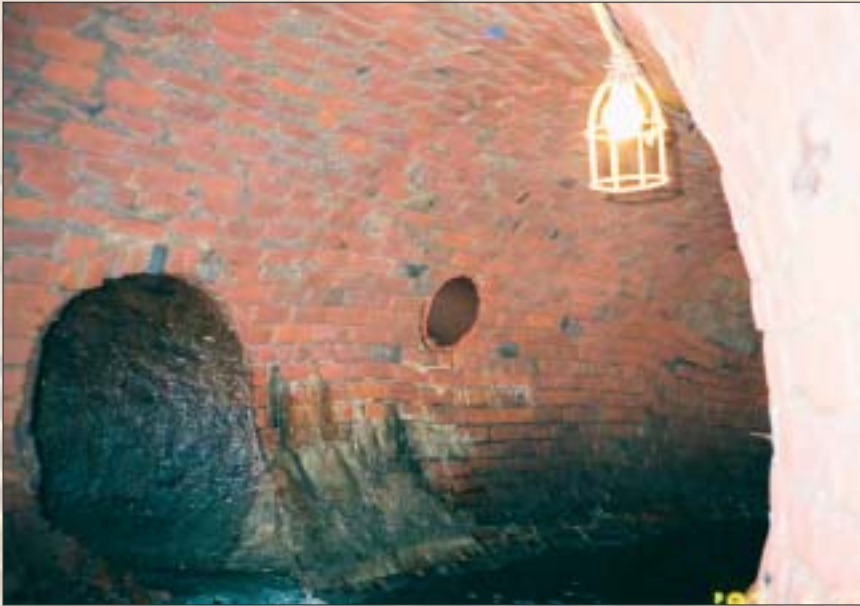
*The 90-degree bend with a 30-in. side connection before repair.*

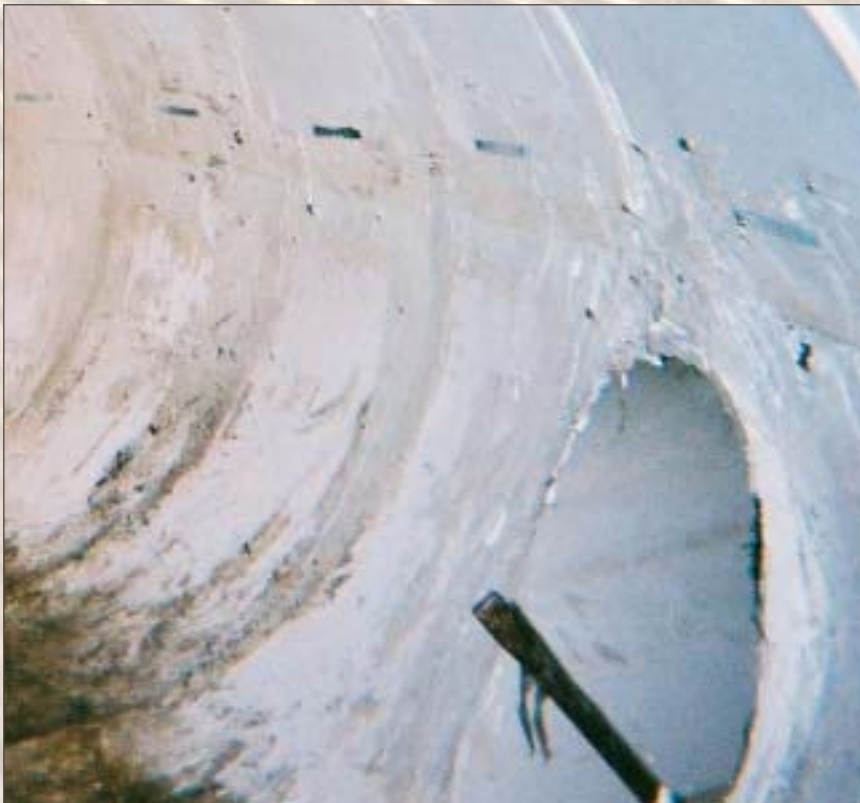
*The 90-degree bend with a 30-in. side connection after repair.*

Affholder had to first reestablish the connecting sewers. The contractor completed five lateral reinstatements, including one 30-in. connection in the 90-degree using a saw with a diamond-tipped blade to cut an appropriately sized hole through the panel. The lateral was then reinstated with an inserted PVC pipe set in place with epoxy. After the epoxy cured, the PVC pipe was cut flush with the inside surface of the panel and the annular space grouted.
