Bridge Replacement Overcomes a Host of Challenges

When even solutions present difficulties

The Route 300 Bridge in Newburgh, NY, was in a dangerous state of disrepair, but designing and constructing a replacement would be no easy matter. Ordinarily routine issues, such as the relocation of utilities, the rigid frame design, and bridge instrumentation, were beset by unusual conditions that posed thorny problems for the design and construction teams.

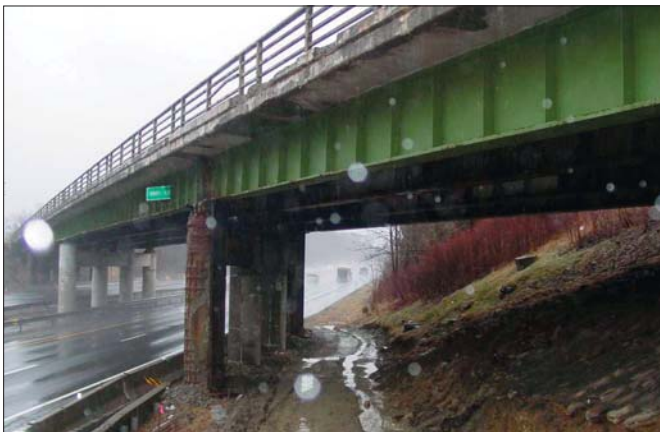
New York State Department of Transportation inspectors discovered that the outer columns and pedestals of two of the piers had deteriorated badly.

deck, sidewalks, and all five substructures had decayed badly. In particular, the outer columns and pedestals of two of the piers had spalled to the extent that the fascia girders were temporarily supported with steel columns.

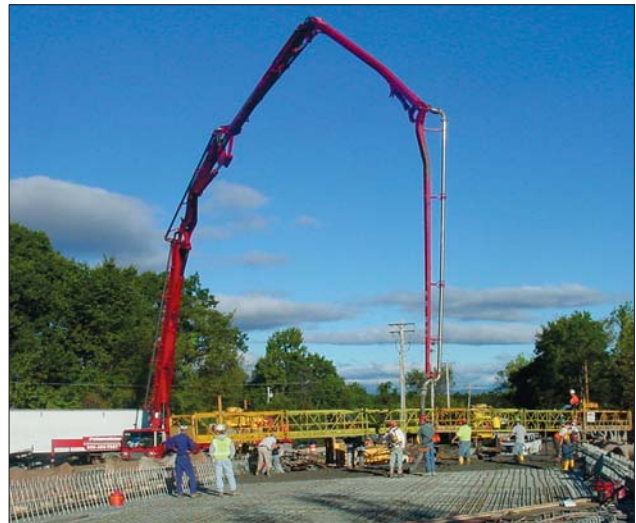
All phases of construction were affected by the dramatic skew of the bridge — 58.5 degrees.

The dramatic skew of the bridge—58.5 degrees—affected all phases of construction and added to the complexity of the project. In addition to the difficulties with the rebar, the connections at the piers between the two girders and the connection at the abutments also raised concerns. At the pier, bolted field splices had to be installed and rebar had to be passed through all the girders after a significant portion of the rebar had already been installed. Space constraints, often unforeseen, also contributed to the difficulty of proceeding with construction and keeping the project on schedule.

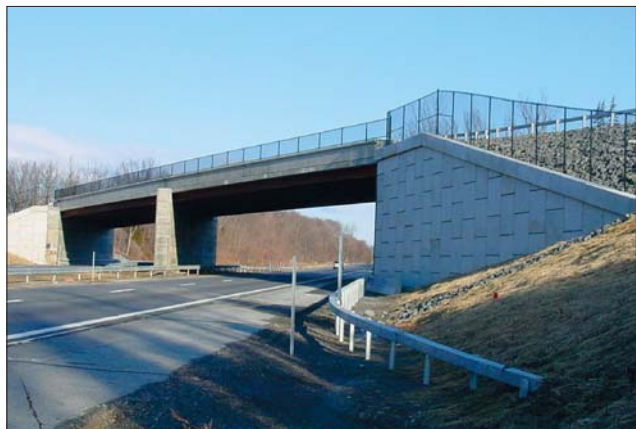
The completed project stands as testimony to the effectiveness of the informal partnering and collaboration of all agencies involved.
