# Cooperative Manhole Restoration

By Don Newman and  
Karl Sauereisen

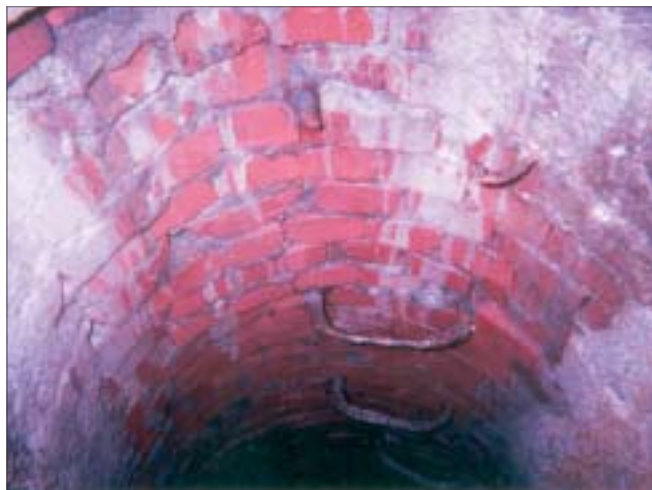
*The necessity for rehabilitation is evident in this Lowries Run manhole.*

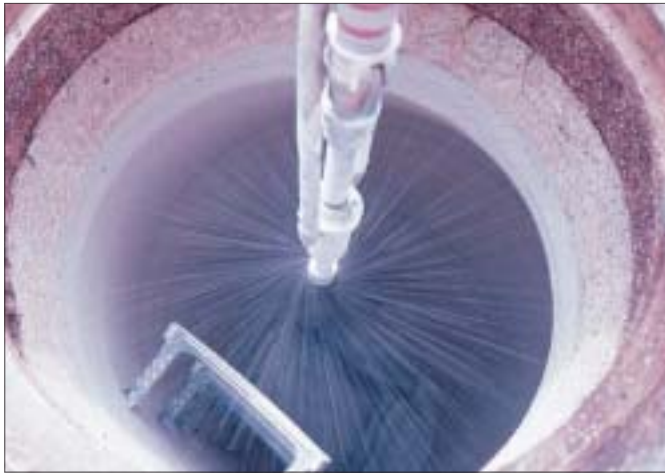
*The majority of lining applications within Lowries Run manholes utilized spincasting technology from ground level.*

MTSA liked the concept of executing manhole rehabilitation from street-level, and so they worked together with Sauereisen in finding a way to mechanically apply the restoration material. What they conceived was a manner of pumping the H<sub>2</sub>OPruf through delivery hoses and then having the product sprayed onto the manhole walls by a rotating spincaster. The air-powered

spincaster was lowered and raised within the manhole until an approximate thickness of 1/8-in. was attained in just 20 minutes.

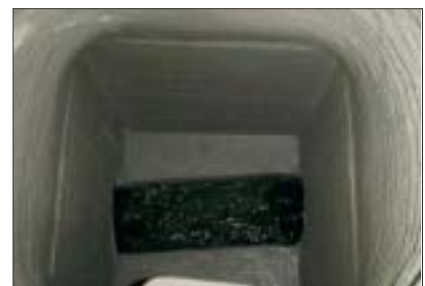
*Typical Lowries Run manhole, post-application: Sauereisen's lining completely restores and seals the concrete vaults and brick chimneys.*

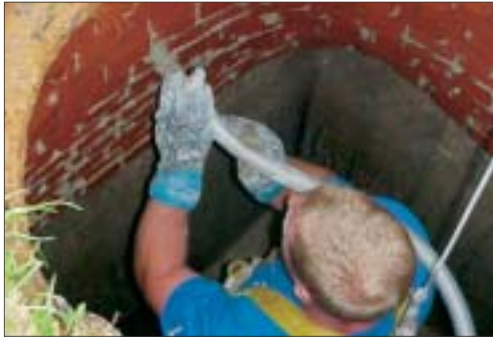
*A cement-based resurfacing material is pumped into open mortar joints within manhole chimneys.*

During the installation stage, Sauereisen technical service consultants Greg Maloney and Pete Jansen frequently accompanied Buehler and his crew to troubleshoot unforeseen challenges. In a rare instance where material mixing could not occur in the immediate vicinity of a manhole, the H<sub>2</sub>OPruf was successfully pumped 200 ft. On multiple occasions, the crew found it difficult to attain full spincasting coverage on the underside of brick in the chimney section of manholes. In these cases, the spinning nozzle was removed from the

end of the hose and an applicator quickly “battered” open spaces as needed.

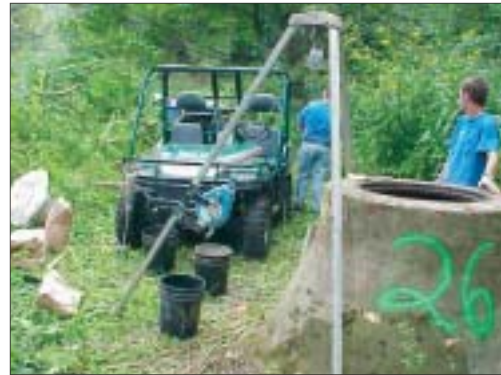
*All-terrain vehicles transport materials and lightweight equipment to the more remote locations of Lowries Run.*

To their credit, the MTSA crew, led by field supervisor Steve Buehler, became experts in staging materials and equipment in a manner that minimized downtime. For transporting equipment to some of the more remote manhole locations, they utilized their fleet of military surplus vehicles that had been purchased economically and refurbished. It helped that the rotor/stator pump used for the H<sub>2</sub>OPruf was a fairly small, lightweight model. The necessity of crossing streams and traversing wooded habitats would have been impractical with most of the big and heavy rigs popular in the industry.
