Island Community Solves Wastewater Treatment Problems

An island community solves its long-term wastewater treatment needs with a new 72,000-gpd treatment plant.

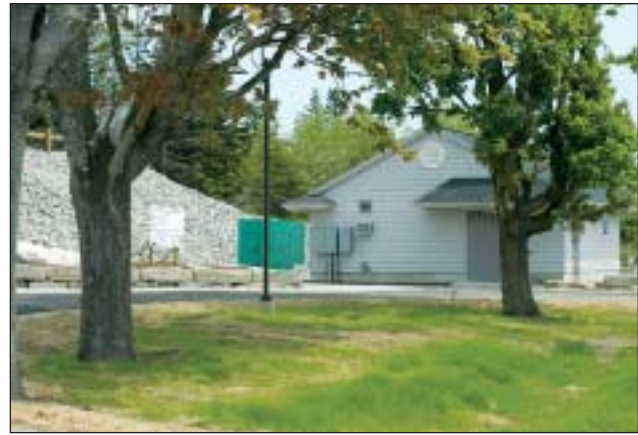
The facility employs ultra-violet disinfection, which eliminates the need to ship to and store chemicals on the island.

The 72,000-gpd facility serves the village area, which comprises nearly 400 users. In addition to the primary treatment system and a package secondary treatment system, the plant includes a wood-frame ultraviolet disinfection building built by the general contractor and equipped by Wedeco North America (www.pci-wedeco.com), an effluent pump station, and an ocean discharge outfall. Ultraviolet disinfection was the method of choice for Vinalhaven because it would not require the use of chemicals, thereby eliminating cost and safety concerns of shipping chemicals to, and storing them on, the island. By eliminating chemical disinfection from the treatment process, disinfection by-products are not an issue, removing concern about their impact on ocean ecosystems and the habitat.

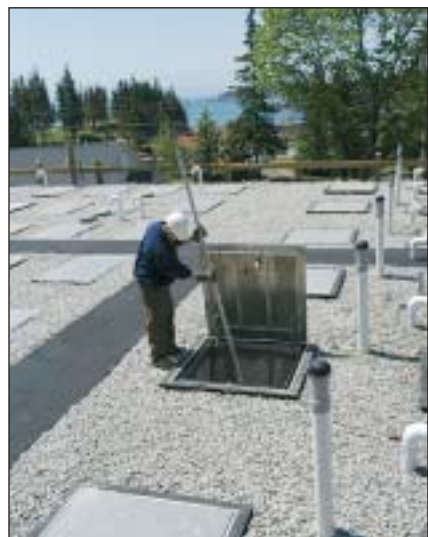
Woodard & Curran engineer Tom Hazlett checks a trickling filter at Vinalhaven's new 72,000-gpd wastewater treatment facility.
