Stabilization of Shade Landfill Deep Mine Workings

Mine voids and overburden fractures are grouted.

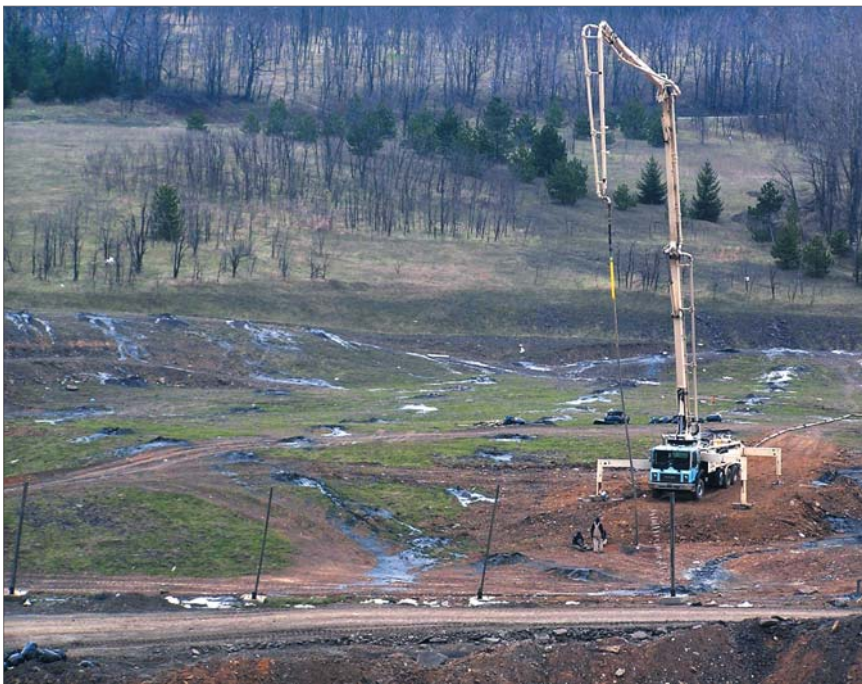
Panoramic view of grouting operations at Shade Landfill in Pennsylvania.

Grout, consisting of fly ash, sand, cement, and water, was mixed on-site. Grout consistency was adjusted to provide high slump barrier grout or flowable production grout. A concrete pump truck was used to deliver grout to the

bottom of each borehole using a tremie hose. CEC's technician logged grout placement, verified grouting was conducted in accordance with the plan, prepared test cylinders, and conducted slump flow cone tests. A total of 11,600 cu yd of grout was placed, ranging from

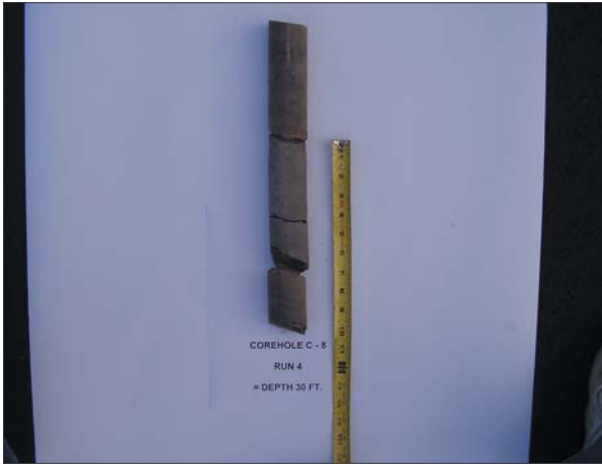
Grout column between intact rock layers.

These observations provided indirect evidence grout had infilled gob, fractures, and voids. Direct evidence was provided in core samples that contained grout ranging from thin lenses between fractures, conglomerates of grout mixed within gob rubble, or columns of void-filling grout.
