# Minnesota Park Project

A public institution combines restoration of wetlands with improved water quality, solving a complex problem through creative design and innovation.

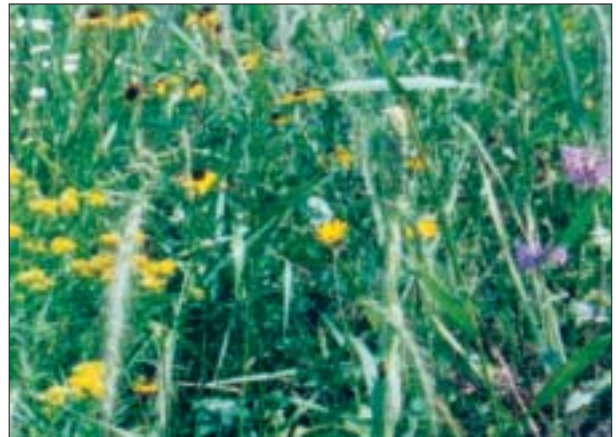
*Particular attention was given to designing an area that would closely mimic native conditions. This photo of the upland prairie plant community is one of the four habitats planned for the site.*

The native plants compete successfully with undesirable species and minimize their presence on the site. More than 8,434 seedlings and 238 trees and shrubs were included in the design, with about 100 species. The seed mixes were grouped into shallow marsh, wet meadow, and upland prairie vegetative types. Specifications for seedlings were developed for planting the earthen weirs and random groups throughout the site.

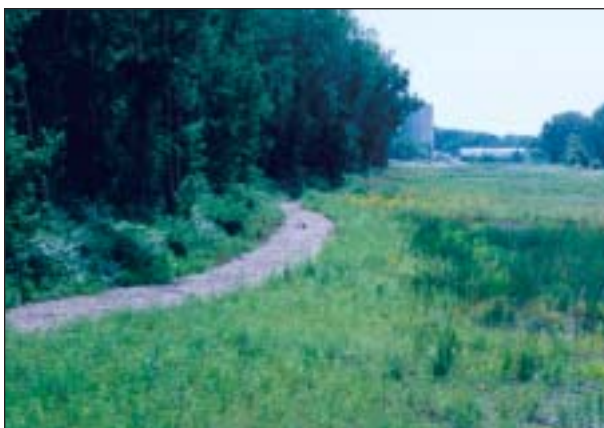
*This is a view from the parking lot, facing west, during the first growing season. The dark patch is a native bulrush growing in the nearby basin surrounded by wet meadow species.*

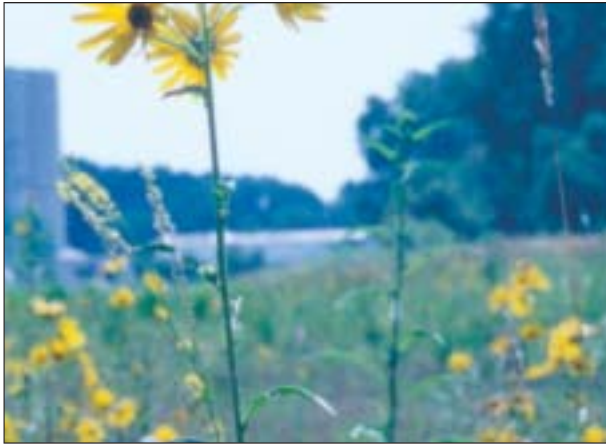
*An example of the diverse flowering native species within the wet meadow plant community during the second growing season.*

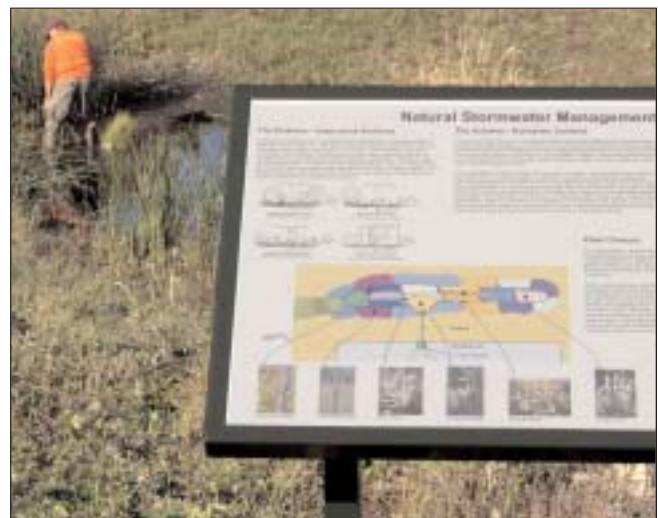
*The consultant developed two information signs that illustrated the workings of the rain garden and wetland restoration steps. This photograph is one of the signs with the rain garden being maintained in the background.*

A rainwater garden was designed and installed in association with the new parking facility. Located in a public space, the rainwater garden provides a high level of water quality and a sustainable design that can be viewed and enjoyed by the public. When construction was complete, the city decided to provide public access and signage for the restoration site and rainwater garden. URS developed two information signs that illustrate the workings of the rain garden and wetland restoration steps.
