Test Center Bridge Needs Special Care

Containment and coating system key to award-winning project

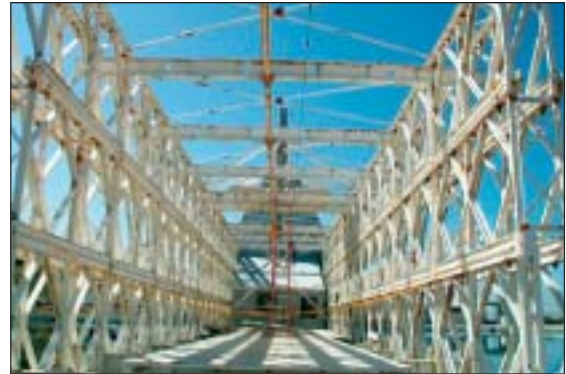
After years of exposure to weather and salt spray from the Pacific Ocean the bridge's steel trusses needed repair. Prior to painting, workers pressure washed and sand-blasted metal surfaces to clean the substrate of rust, dirt, and old paint.

Before any new coating could be applied to the bridge and the exterior of the test lab, all metal surfaces had to be pressure washed and sandblasted to clean the substrate of rust, dirt, and old paint. Workers also did a lot of hand scraping to make sure surfaces were as clean as possible. TCI hired mechanical welding experts to replace old welds and add new steel plates to various sections.

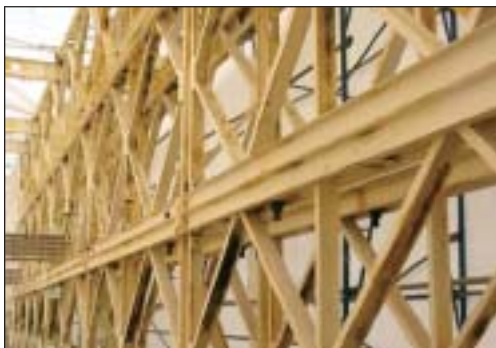
Containment was critical to preventing dirt, debris, and overspray from dropping into the pool where it could interfere with sonar testing. TCI wrapped huge plastic sheets over scaffolding and under the flooring to trap and catch debris, while surfaces inside the containment area were frequently vacuumed.

For containment, TCI started by building scaffolding around the bridge. To reach the underside, a wooden drop floor was secured to the scaffolding. To make room for the flooring beneath the bridge, McManus lowered the pool water level by about four ft. Huge plastic sheets were tented over the scaffolding and under the flooring to trap and catch any loose paint, rust, or other materials that might fall from the bridge during the work. Disposable drop cloths were also spread across the flooring so that all the debris could be collected there. Workers kept the area neat by frequently sweeping, vacuuming, and disposing of waste materials.

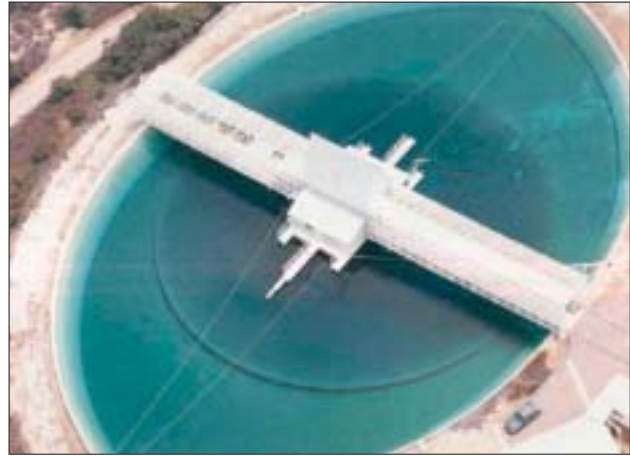
TRANSDEC, part of the Navy's Space and Naval Warfare Systems Center San Diego, is one of the main locations for testing and recalibrating communication acoustic devices for underwater warfare. After years of exposure to the elements, the bridge's trusses required rebuilding, repair, and repainting.

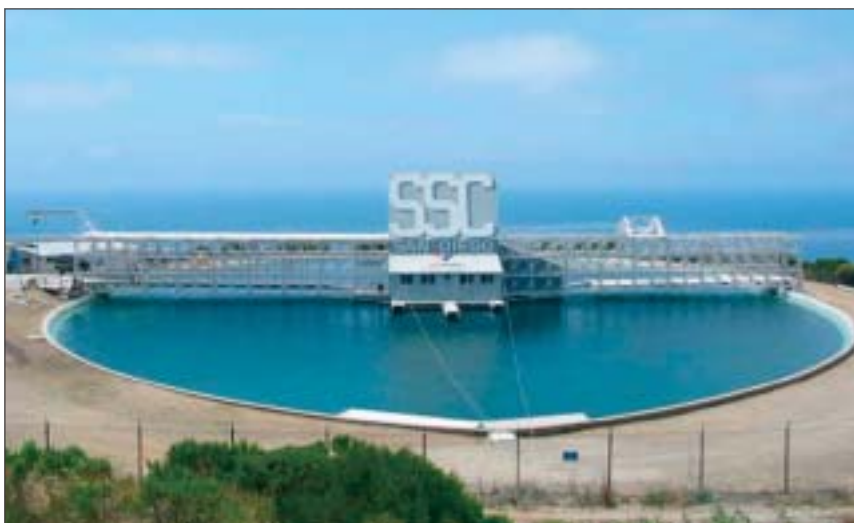
Located less than a mile from the Pacific Ocean, the bridge allows easy access to all areas of the man-made water basin. Pilings are located outside the water so the pool is clear of objects that interfere with sonar testing.
