# Utility Looks for Leaks

Historic utility uses the latest technology to pinpoint problems.

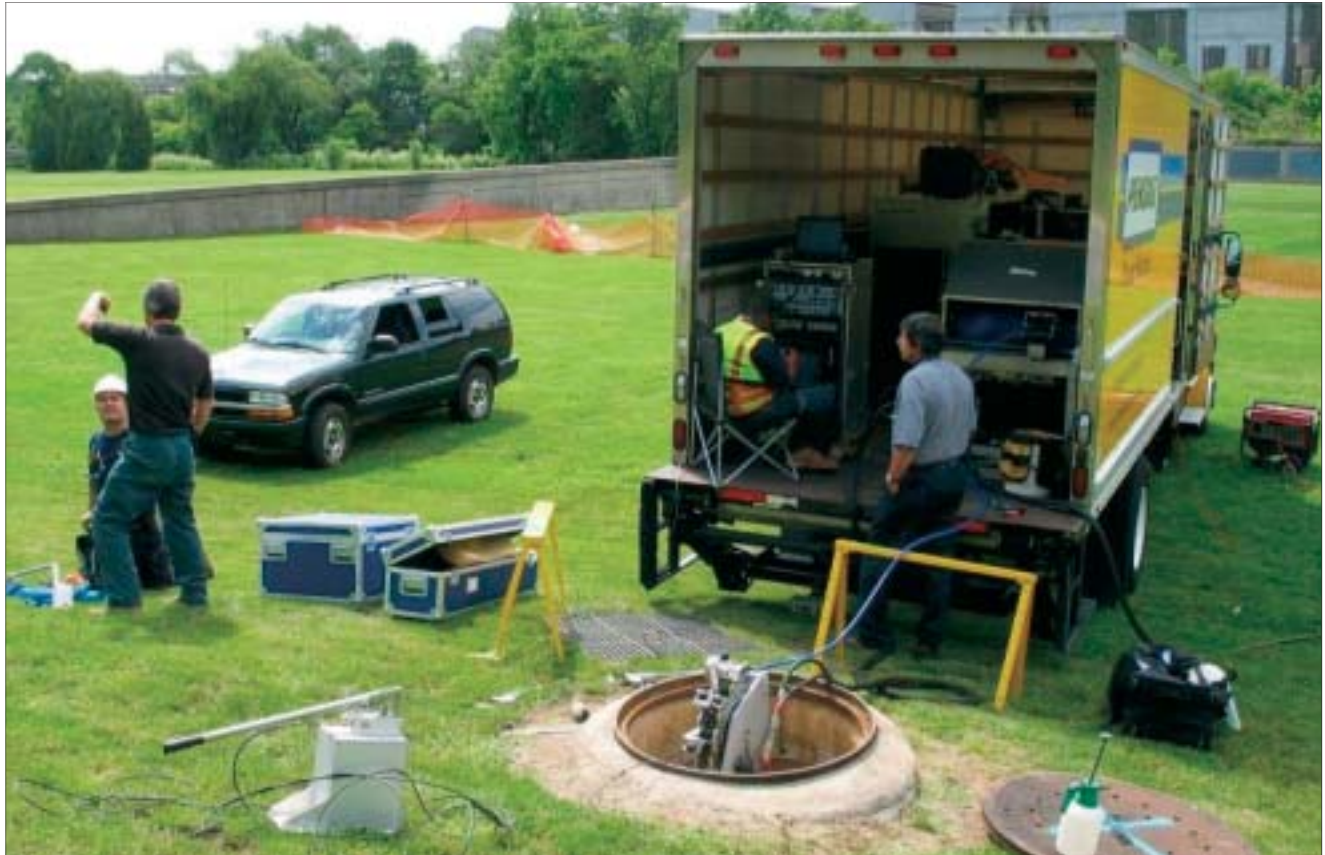
*Sahara System set up on the East Side Transmission main in Allentown, PA.*

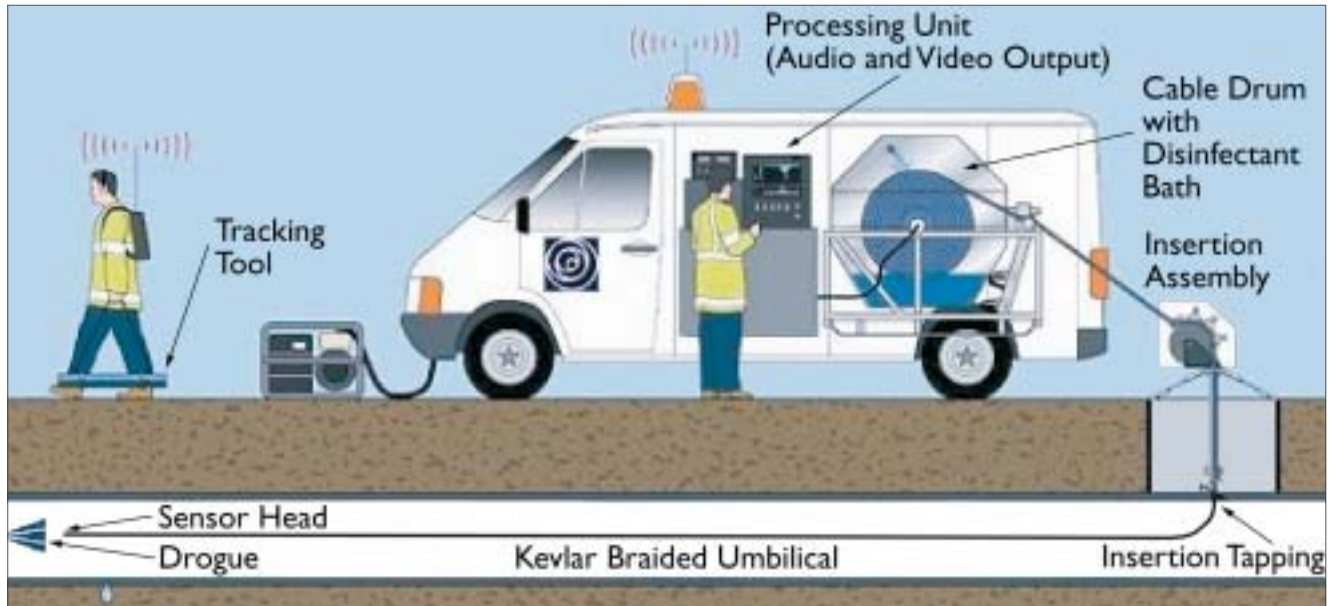
*The acoustic sensor element is permanently encapsulated in chloroprene rubber, which has been specially compounded to ensure acoustic impedance. The drogue chute, attached to the sensor at the end of the cable, ensures correct deployment of the equipment within the pipe by providing the force to pull the sensor through the pipe. The tethered umbilical cable is neutrally buoyant in water. The insertion mechanism accommodates the introduction of the system into a live under-pressure pipeline through a two-in. tap. The cable drum is a stainless steel framed, hydraulically operated, and completely encased spooling machine. Both audio and visual data are delivered to the operators.*

The Sahara system detects leaks in a pipeline by sensing the noise generated by a leak. As the sensor head travels along the pipeline, sounds within the pipe are picked up by the hydrophone in the sensor head. The system feeds the signal from the sensor head through the cable into the cable drum, which passes through contactors in the slip ring to the interface processing equipment for interpretation by the software and the operator.
