In Katrina's Wake

Two bridges destroyed by Katrina are replaced, reconnecting the Mississippi Gulf Coast.

By Kent B. Dussom

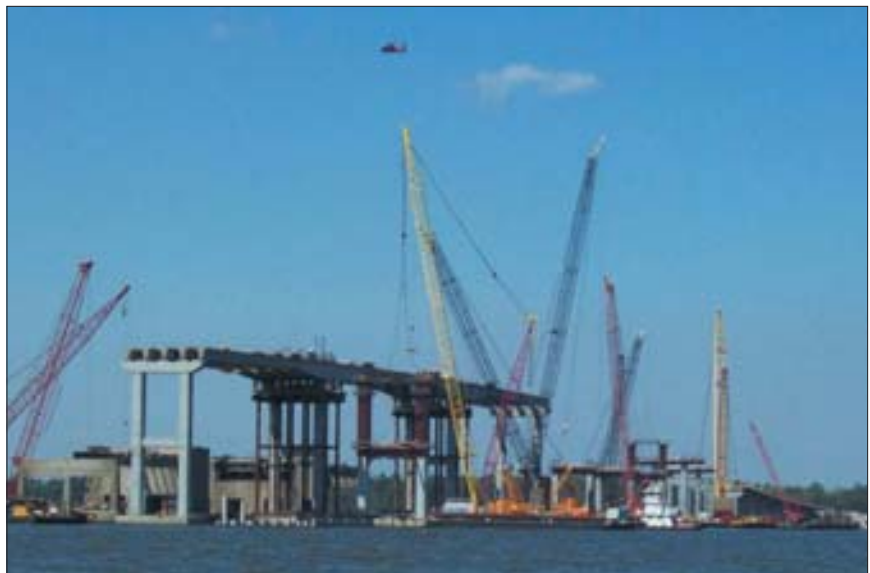
The westbound main navigation span on the US 90 Bridge over Biloxi Bay was set on April 24, 2007.

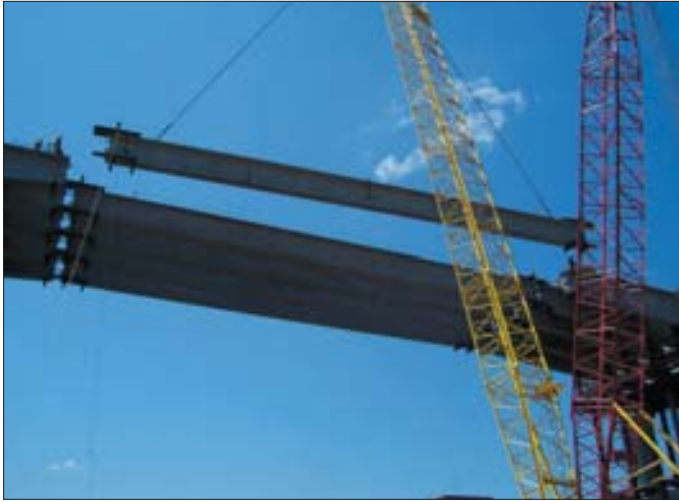
The main navigation span provides 250-ft horizontal clearance and 95-ft vertical clearance.

The original drawbridge was replaced with a higher and sturdier bridge designed to survive future storms. The new bridge provides 95 ft of vertical clearance at the navigation channel to accommodate marine traffic. Similar to the St. Louis Bay Bridge, the new Biloxi Bridge provides longer, heavier spans and shear keys on the approaches to the

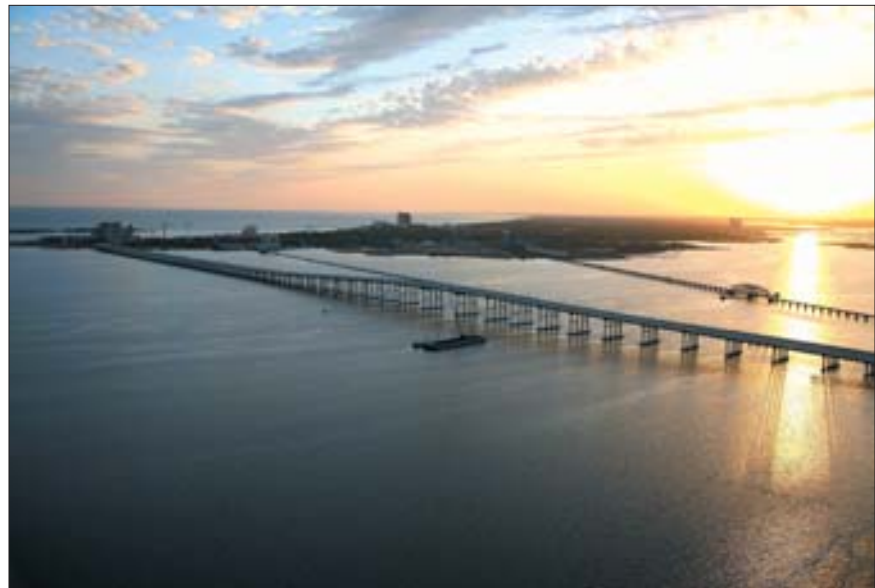
The Biloxi Bay Bridge connects Biloxi on the west with Ocean Springs on the east. Photo by John Thomas Photography.

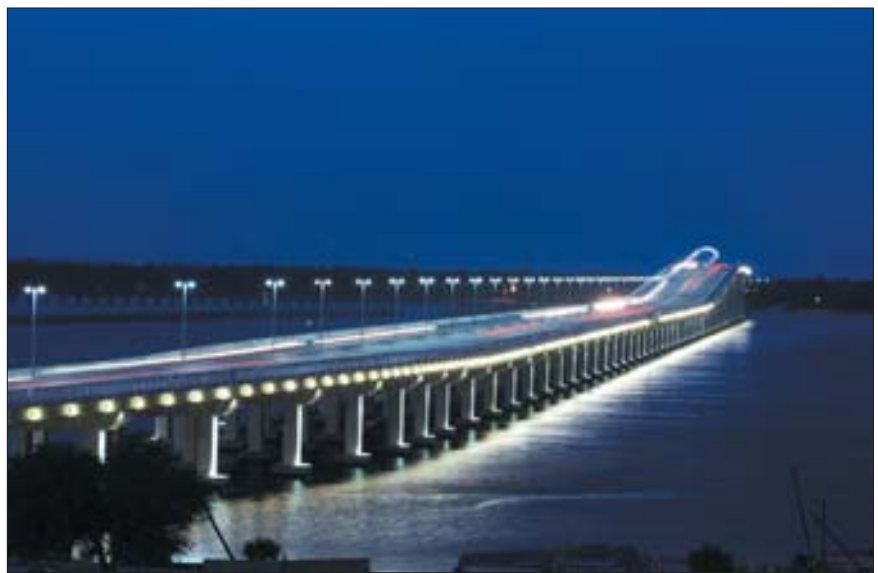
The Biloxi Bay Bridge lighting illuminates both the edge beam and the piers. Photo by John Thomas Photography.

Additionally, both bridges have ribbon lighting along the outside beams and down cast lighting on each of the piers. The subtle lighting makes the bridges a breathtaking view at night.
