Hillery Street Bridge Spans Three Centuries

Replacement bridge recaptures historic past.

By Bruce J. Karalius

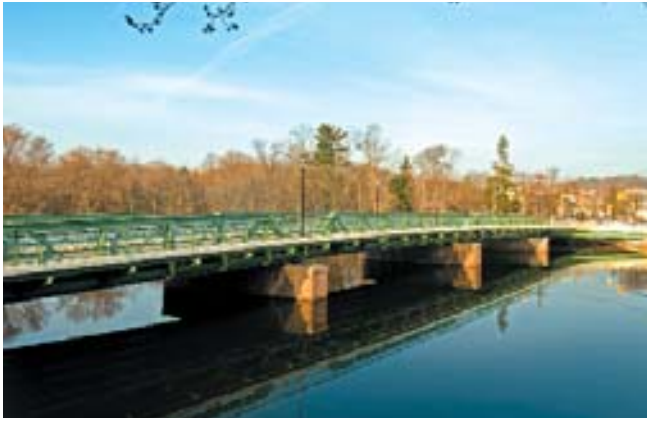
The new Hillery Street Bridge replaces the original, built in 1898. The original was a four-span, simply supported, riveted Pratt Pony Truss carrying one lane of traffic in each direction across the Passaic River in northern New Jersey.

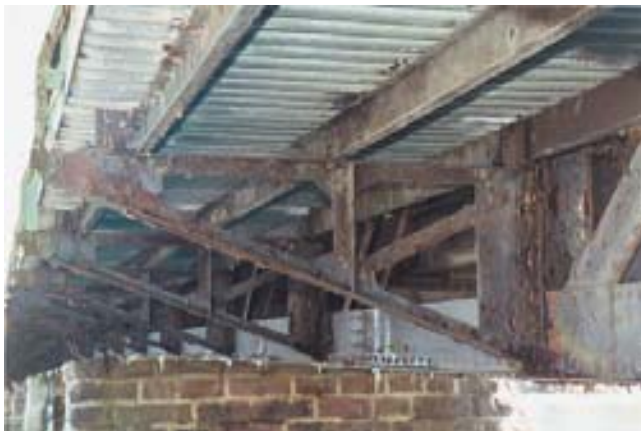
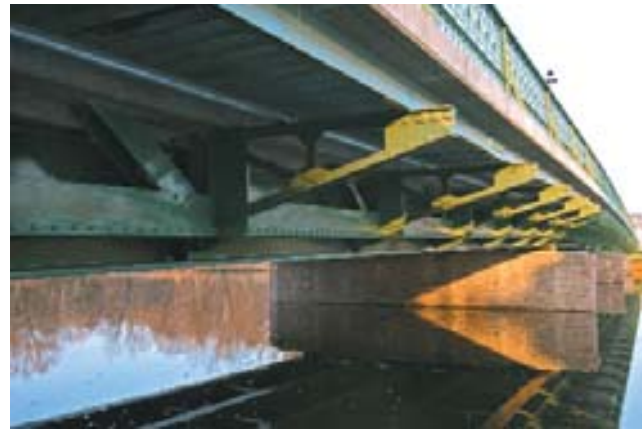
At left is a view of the sidewalk brackets and lower portion of the truss on the original Hillery Street Bridge. At right, a view of the new cantilevered sidewalk brackets from the underside of the replacement bridge.

To preserve the remaining trusses as part of the new bridge, they were integrated into the structural framework of the superstructure. The cantilevered sidewalk brackets were connected to gusset plates attached to the trusses in the same manner they were connected in the original bridge. The gusset plates were then attached to the fascia beam. In this manner, members of the truss still assist in providing some load-carrying capability.

To resist moment created by the sidewalk loads on the cantilevered sidewalk brackets, W24 steel beams were used as diaphragms, which transform the moment from the cantilevered sidewalk into reactions, which were then resisted by the beams. To provide rigidity, the W24 diaphragms were used throughout the entire framing plan and not only in the fascia bays.

The cantilevered sidewalk brackets, which are mostly composed of double angle components, were replaced in-kind, except the thickness of the angles was increased from 1/4 in. to 3/8 in. to meet current state requirements. The

sidewalk brackets were placed at the panel points of the trusses.

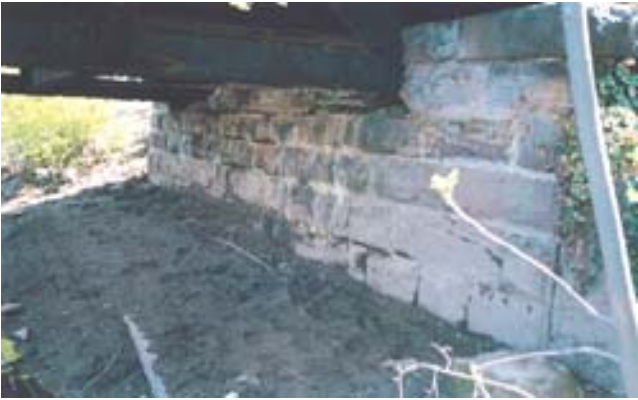
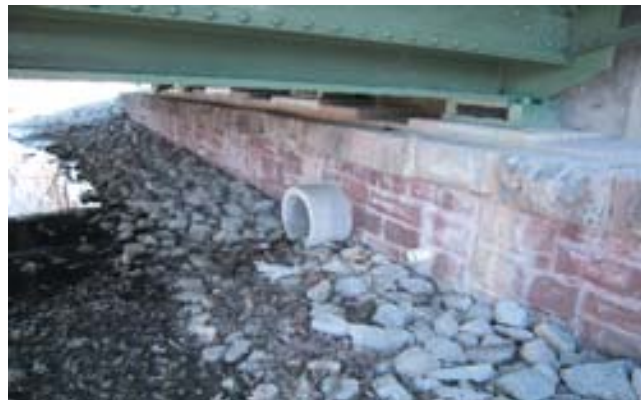
Once both abutments were relaced with new reinforced concrete abutments founded on spread footings, stone facing was attached that replicated the general color and appearance of the original stone.

The criteria to reuse the existing trusses required the span lengths of the new bridge to be the same as the original bridge; hence new substructure units needed to be placed at the same locations as the original units. This requirement necessitated complete removal of the existing piers and installation of four-ft diameter drilled shafts in their place. Accordingly, four drilled shafts

were installed at each pier. Atop each of the drilled shafts a cast-in-place reinforced concrete pier cap was constructed. The pier cap extends from just below the mudline to the bottom of the beams. Stone facing was then attached to the pier caps. Additionally, both abutments were also removed and new, reinforced concrete abutments were founded on spread footings.

As with the piers, stone facing was attached to the abutments and wingwalls. The stone facing was originally intended to be fabricated with stone blocks from the original piers and abutment. Unfortunately, since the stone was too severely deteriorated and cracked, it could not be reused. Therefore, other stone that replicated

the general color and appearance of the original stone was used. The original capstones, which were composed of a harder stone than that found in the original piers and abutments and wingwalls, were in a condition suitable to be reused as capstones on the new bridge piers.

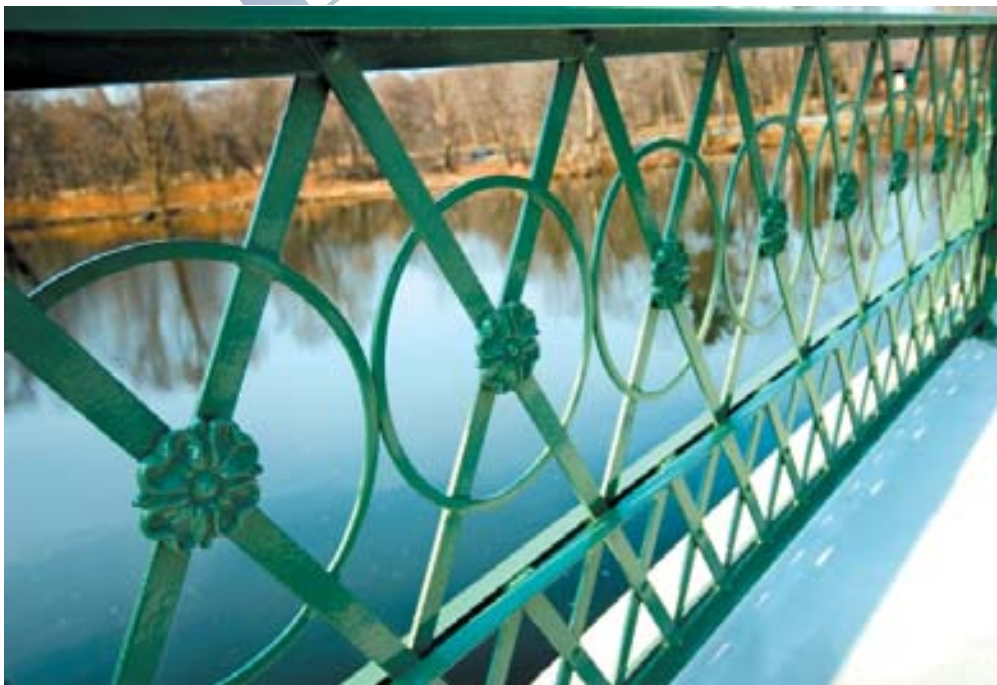
The steel ornamental pedestrian railing decorated with a pattern of rosettes, was in fairly good condition so it was reused on the new bridge. The railing did require a modification because it did not meet current geometry and safety requirements; the railing openings were too large. To correct this condition, a steel, circular-patterned component was installed on the top portion of the railing to reduce the size of the opening. The thickness of the material for this element was minimized so as not to detract from the overall appearance of the railing yet function structurally and meet current code requirements.

The original pedestrian railings along each sidewalk were cleaned, repainted, and used in the same fashion on the new bridge.
