No Sedimentation Pond? No Problem.

By John Haukaas

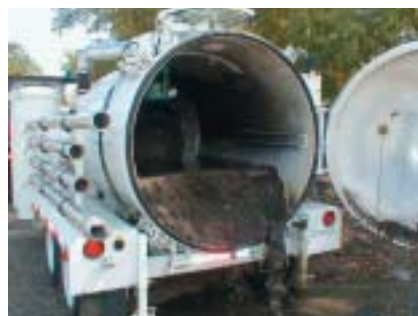
Pumper truck containing sediment sludge pumped from the swirl chamber.

Miller did the first post-installation maintenance in Spring 2002. In July 2003, Fridley performed another maintenance program. Over two and a half days, crews removed 11 yd of material from both systems—one had been three quarters full; the other, half. No washout of trapped pollutants was detected.

Fridley's three-person maintenance crew starts with pumping of all the water until only material remains. A jetting machine creates slurry that is vacuumed. The waste is disposed of at a local waste treatment facility.

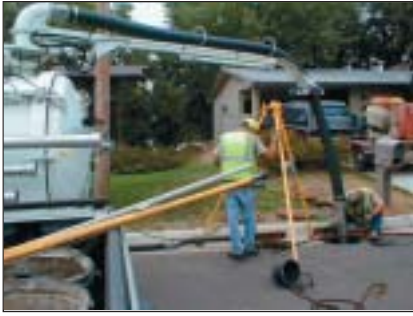
For ease of pump-out, access openings were located next to the curb.

Kottsick says the systems are easy to maintain because they have been installed behind curbs and are easily accessible. "One aspect you definitely want to consider when setting these structures up for installation is the ease of maintenance and accessibility. You don't have a bunch of components inside the structures that would block getting the tube of the vacuum truck to get in there and clean it out. We normally try to put two openings in each structure so that they can reach from two sides of the manhole with their vacuum truck." **GE**
