Digging Deep into the Details

A preservation and restoration project at the historic Kansas capitol building required a detailed geotechnical analysis.

By Scott T. Anderson

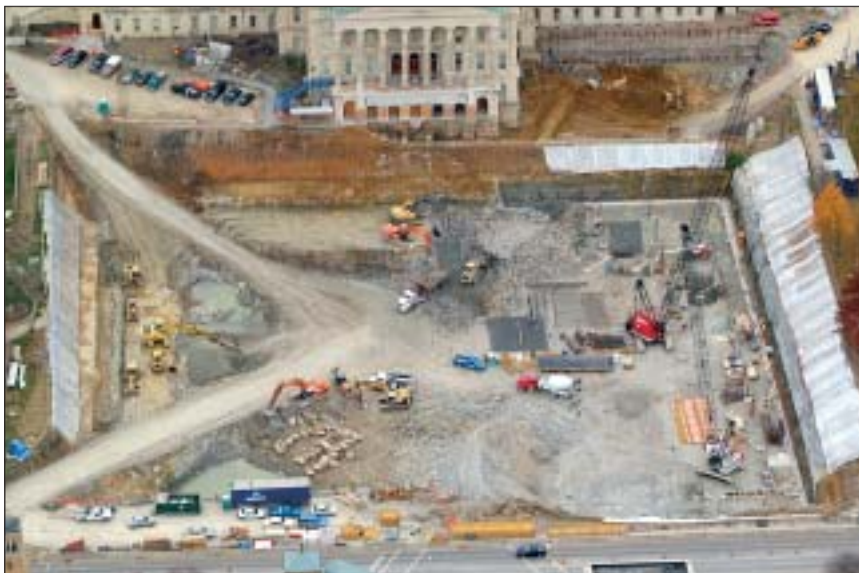
Aerial view of parking garage and northwest mechanical vault construction.

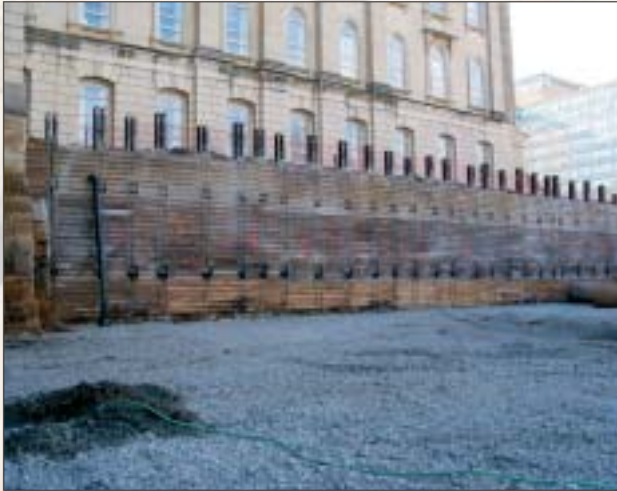
Completed soldier pile and lagging wall (with tiebacks) for northwest vault construction, looking south.

Lateral or horizontal support—the use of a more or less traditional soldier pile and lagging wall with tiebacks — was used to provide lateral support. The soldier piles are made up of channel steel sections welded together to form a stiff structural member. A pier hole then is drilled and socketed into the underlying

bedrock, the soldier pile is placed into the pier excavation, and concrete is placed around the lower portion of the pile.

A sand slurry with a small amount of cement mixed into it then is placed in the remainder of the hole to provide stability to the excavation. Once all of the soldier piles have been placed, the excavation proceeds on the “outside” of the soldier piles, and wood lagging is placed (attached to the soldier piles) as the excavation proceeds.

Once the excavation reaches a predetermined depth, tiebacks are installed. Tiebacks are steel anchor rods that are placed in a drilled borehole and grouted in place; the tiebacks then are tensioned to help the soldier piles resist the lateral forces imposed by the soil.

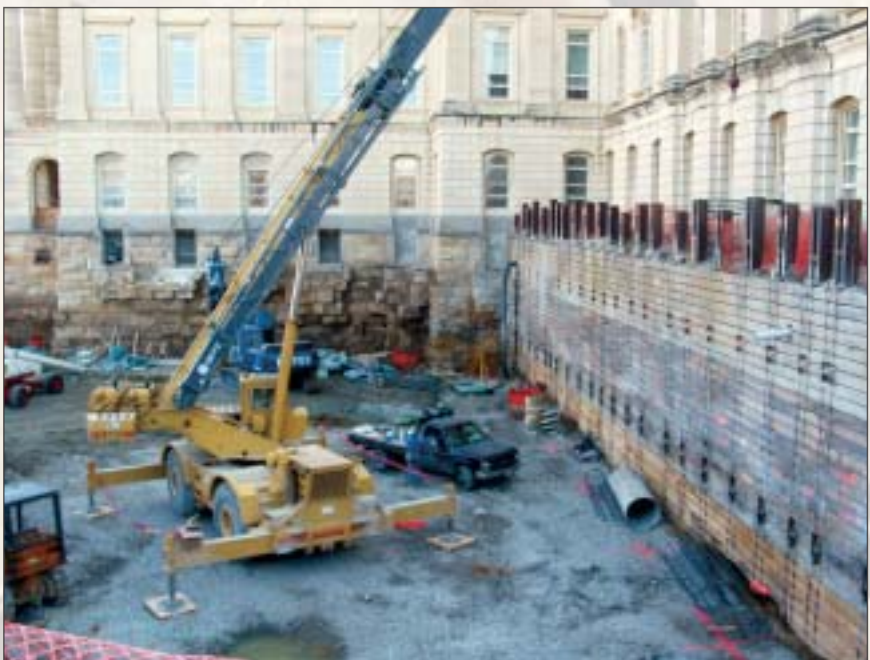
Completed soldier pile and lagging wall — with tiebacks— for northwest vault construction, looking east.

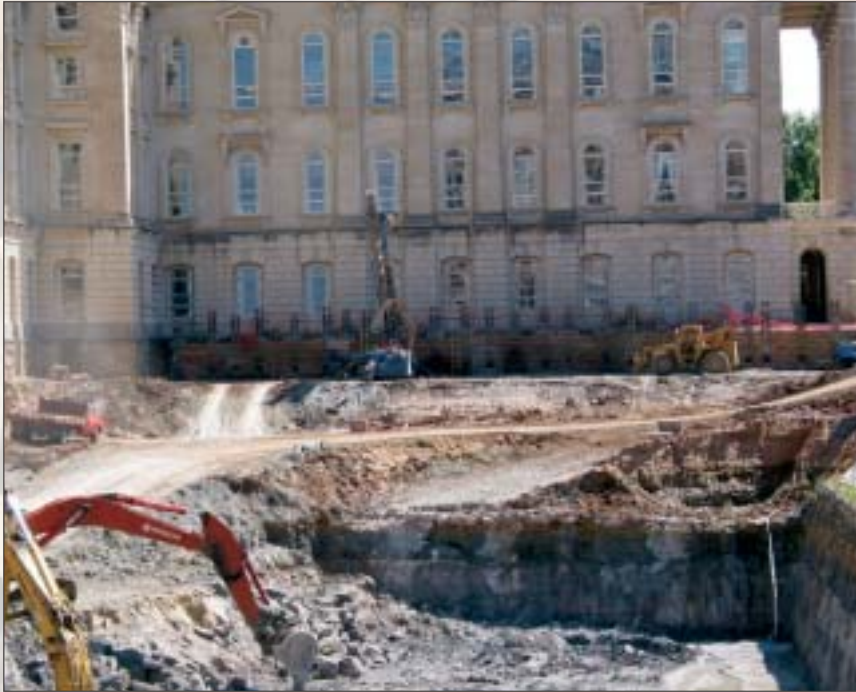
Geotechnical specialty contractor installing tiebacks for soldier pile and lagging wall, northwest vault.
