# Water Treatment Corrosion: Causes and Prevention

## Determining the Condition of Critical Water Assets

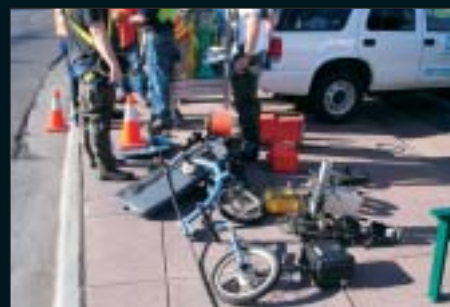
PPIC personnel prepare to enter Conduit No. 30 and assemble PipeRider—a self-propelled RFEC/TC inspection tool.

Conduit No. 30 is a 60-in. diameter PCCP pipeline that was manufactured in 1963 and does not contain shorting straps. Consequently, on August 17, 2005, PPIC conducted a non-destructive evaluation of Conduit No. 30

using its RFEC/TC technology. The inspection was performed between STA 5+32 and STA 60+61, and between STA 63+02 and STA 64+82, spanning an overall distance of 1.08 miles and a total of 366 pipes. Analysis of the data obtained during this inspection determined that only seven pipes (two percent) in this portion of Conduit No. 30 contained broken prestressing wires.
