Airport Link Protects Wildlife Habitat

Missing stretch of highway crosses sensitive ground.

By John F. Muscatell

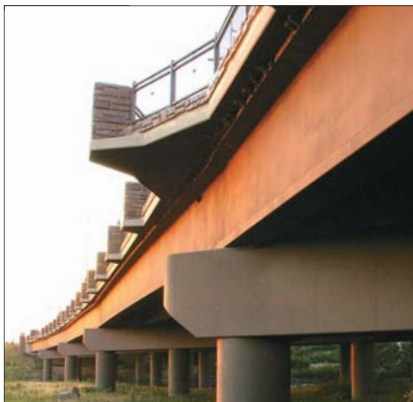
Pedestrians and bicyclists are able to enjoy the scenic landscape from overlooks included on several bridges.

A high degree of attention was paid to the aesthetics of the project. Details on the bridges, pedestrian hand rails, and multi-use trails were created to blend with their surroundings. Several bridges contained an overlook, allowing pedestrians and bicyclists to enjoy the picturesque landscape while remaining safely separated from vehicular traffic.

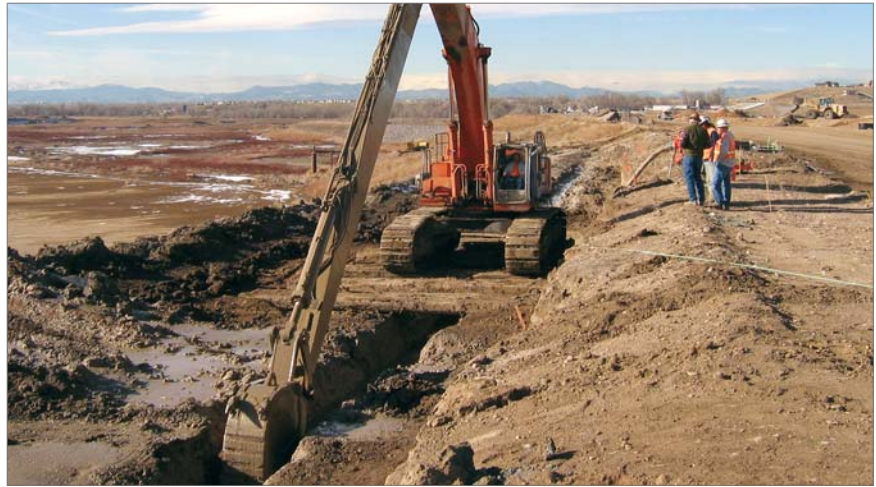
A gravel pit intended as a future water-storage reservoir was protected by a 1,350-ft long cutoff wall designed to separate the reservoir from groundwater.

Another serious challenge involved a proposed water-storage reservoir. The 120th Avenue right-of-way intersected a gravel pit that was intended as a future water-storage reservoir for the Denver Water Board. In order to protect it, a 1,350-ft long cutoff wall was designed to separate the reservoir from groundwater and prevent seepage through the highway embankment.

A two-stage process was used to create the impervious barrier. First, a slurry

mixture formed from powdered bentonite and water was pumped into the cutoff wall trench to keep the steep walls of the trench from collapsing. Behind the slurry came a backfill mixture of native soil and bentonite about the consistency of lava that formed a water-tight barrier.

An innovative technique was required at the eastern end of the cutoff wall where the 65-ft depth exceeded the reach of the excavator. In this section, the wall was constructed in two phases. The first phase was built by benching down and installing the wall up to 53 ft below the bench elevation. Twelve ft of fill was placed over the bench, and the second-phase wall was constructed through the fill, keying into the top of the first-phase wall. The wall allowed the gravel pit to be dewatered in advance, increasing the miner's productivity by saving the constant dewatering costs. It also eliminated groundwater depletion, allowed the county to place the roadway embankment through the gravel pit in a dry condition, and provided Denver Water with a sealed liner for its reservoir.
