Sliplining in Albuquerque

New Mexico city repairs aging interceptors.

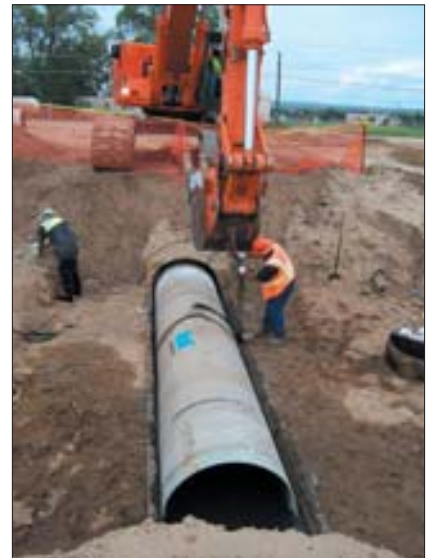
Sliplining pipe is lowered into the trench.

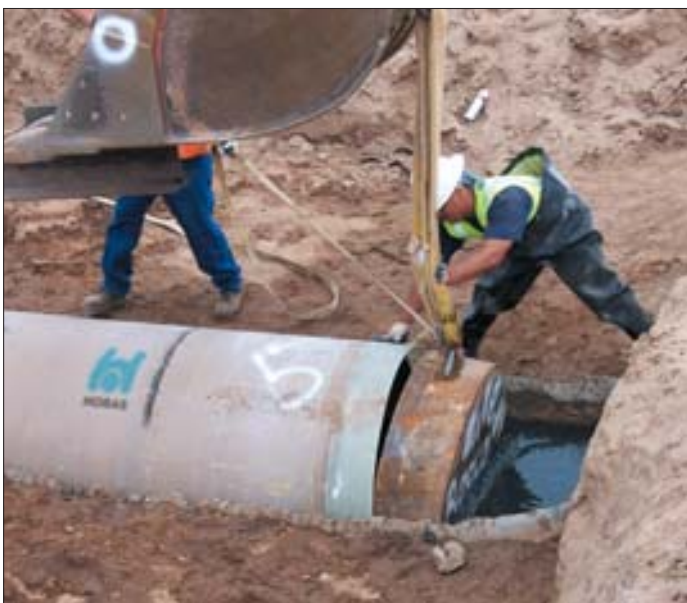
The push ring is placed on the pipe.

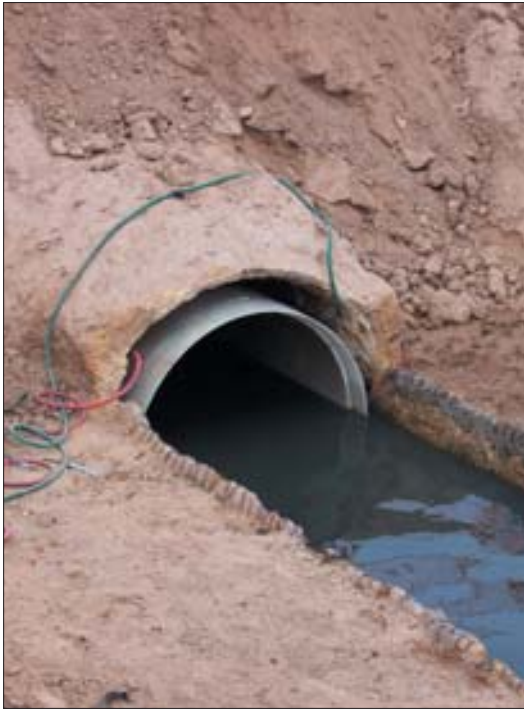
Note the tight fit of the new pipe.

Since the fit was so tight, a mandrel

(proof section) of pipe was pulled through the line before beginning the relining process. The mandrel was an actual section of the sliplining pipe.

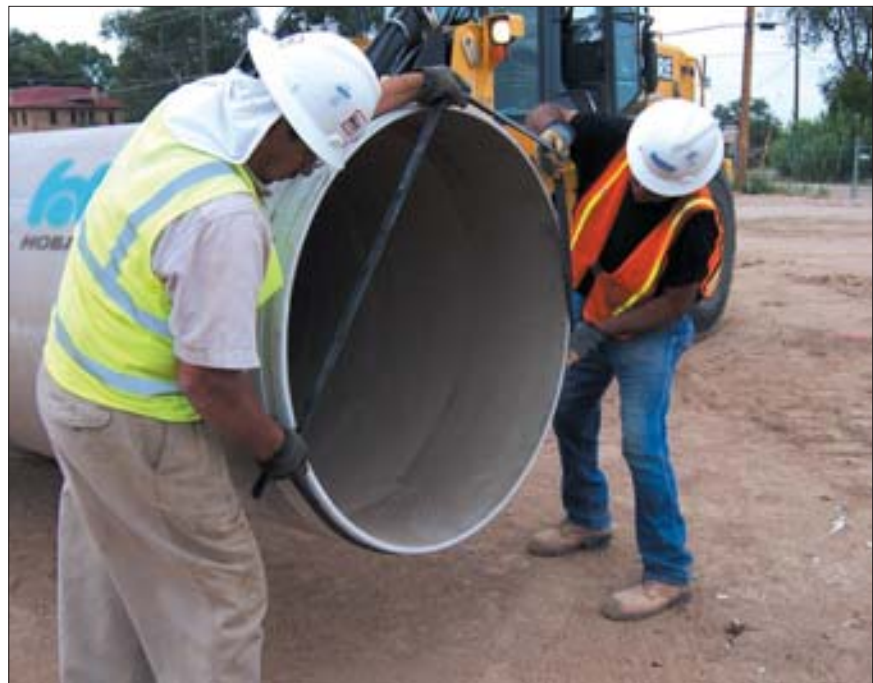
Gasket installation on the new pipe.
