Rolling to Repair

Mn/DOT bridge maintenance crew finds productive solution with screed system.

On Deck: Bridge 5848

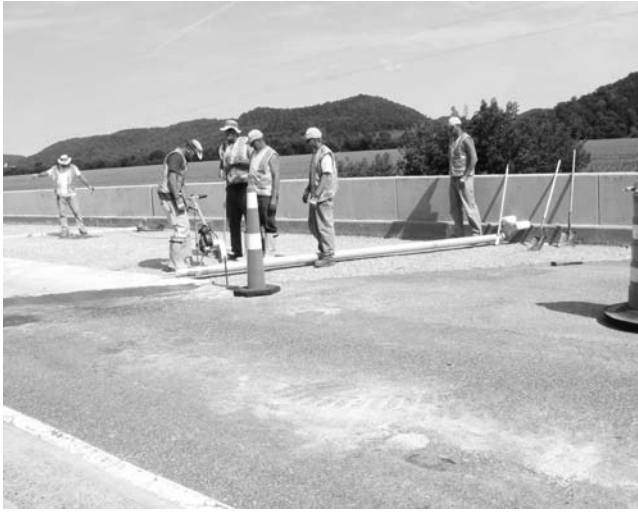
At left, the bridge maintenance crew waits for the mixing truck to arrive after using the Lightning Strike screed to prepare the bridge deck. At right, bridge maintenance crews use the screed while the cement is placed on the bridge deck.

water reducer admixture was added onsite and the trucks were ready to supply the fresh mix. A cement slurry paste was applied just before the pour to act as a bonding agent. An estimated 18 cu yd of concrete were used per lane. After the pour, the Lightning Strike screed was brought in to smooth the concrete to its proper level.
