Open Beauty, Hidden Strength

Despite deep soft soil conditions, a replacement bridge was built quickly by using geof foam as an approach embankment fill.

By Gwendolynn I. Lewis,
Steven Gibbs, and
Kevin Dusenberry

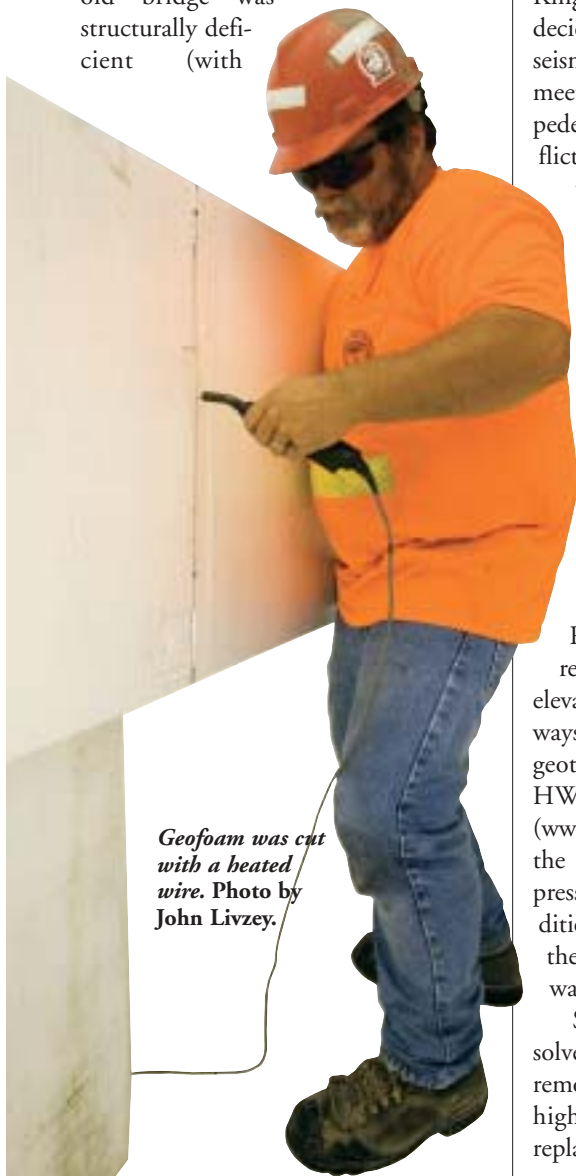
Geof foam was cut with a heated wire. Photo by John Livzey.

achieve the desired roadbed slope and crown, and to fit the material around storm drain pipes and manholes. “These are well-trained carpenters who were putting it in,” says Gilmore, “so they’re used to running a tape measure and figuring out what size piece they need for any given area.” The workers cut the blocks with an electrically heated wire about five ft long, with a handle at each end. After marking the desired cutting lines on the white block with black marker or chalk, two workers would each hold one of the handles, pull the wire tight, and guide it along the lines. With practice, they learned the best setting on the hot wire’s rheostat control and the proper speed at which to move the wire through the block.

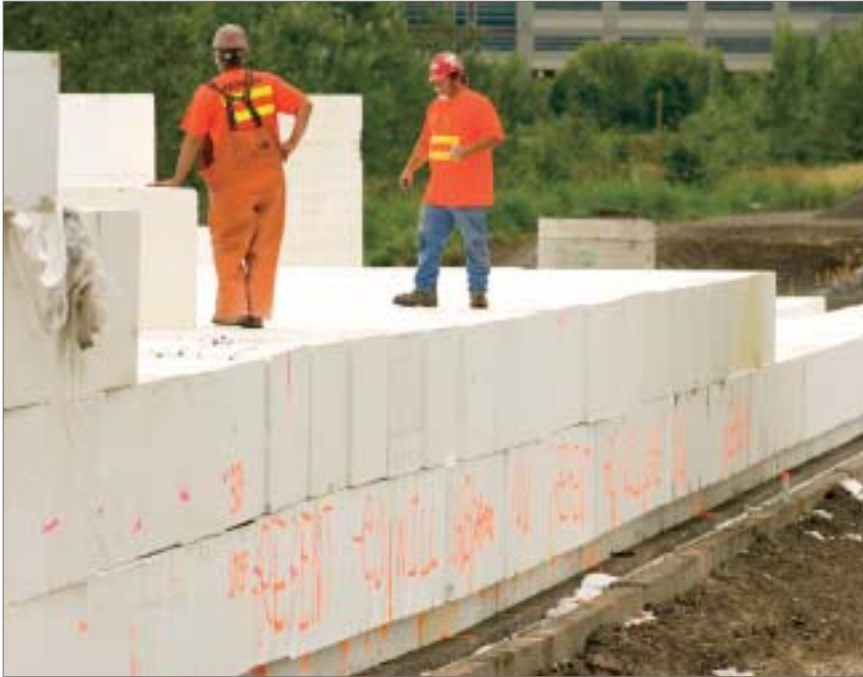
Assembly of the geofoam on the west approach embankment was likened to “putting together a giant, three-dimensional jigsaw puzzle.” Photo by John Livzey.

Another challenge was that the blocks tended to slide as they were being stacked. “We had to run rebar down through some of the edge pieces to make sure that as we were stacking layers we

didn’t knock them out of whack,” says Gilmore. “It was like putting together a giant, three-dimensional jigsaw puzzle.”

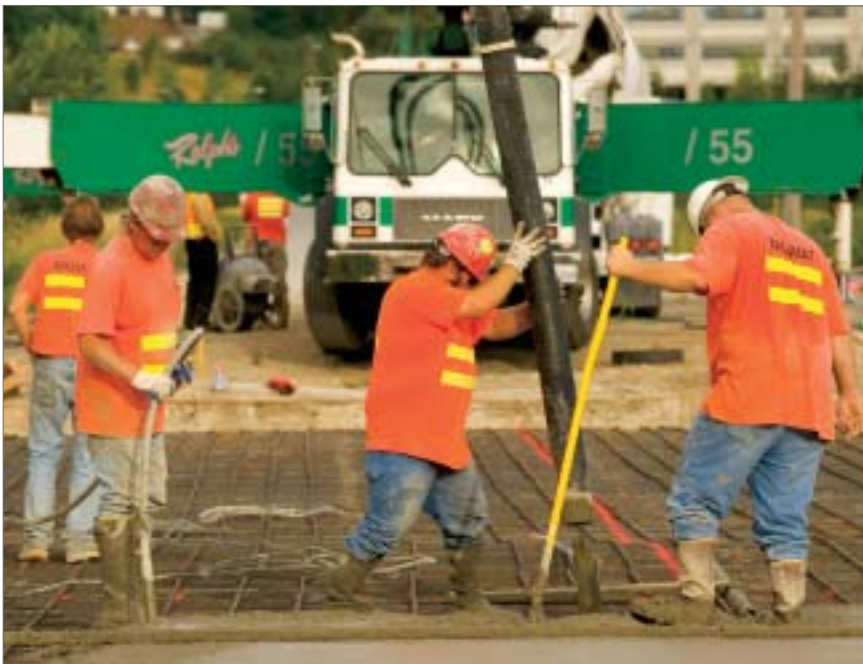
A six-in. thick reinforced concrete slab was poured on top of the geofoam to protect it from solvents and provide lateral support for concrete panels intended to cover the embankment. Photo by John Livzey.

The sequence of constructing the west approach embankment began with removing enough of the existing soil to equal the weight of the geofoam blocks that would be used to increase the road’s elevation. The first layer of the new construction consisted of geogrid soil reinforcement topped with six in. of compacted sand to provide drainage and facilitate leveling. On top of this level surface, the geofoam blocks were stacked up to nine ft high, stopping three ft below finished grade. The blocks—which were typically 2.5 ft high, four ft wide, and eight ft long—were stacked in alternating directions so no seams ran continuously through the layers. When all of the geofoam was in place, a six-in. thick reinforced concrete structural load distribution slab was constructed on top to distribute live loads evenly to the geofoam, protect the geofoam from solvents that could damage it, and provide lateral support for concrete panels that would cover the faces of the embankment. A gravel base and the final asphalt pavement were placed on top of the load distribution slab.

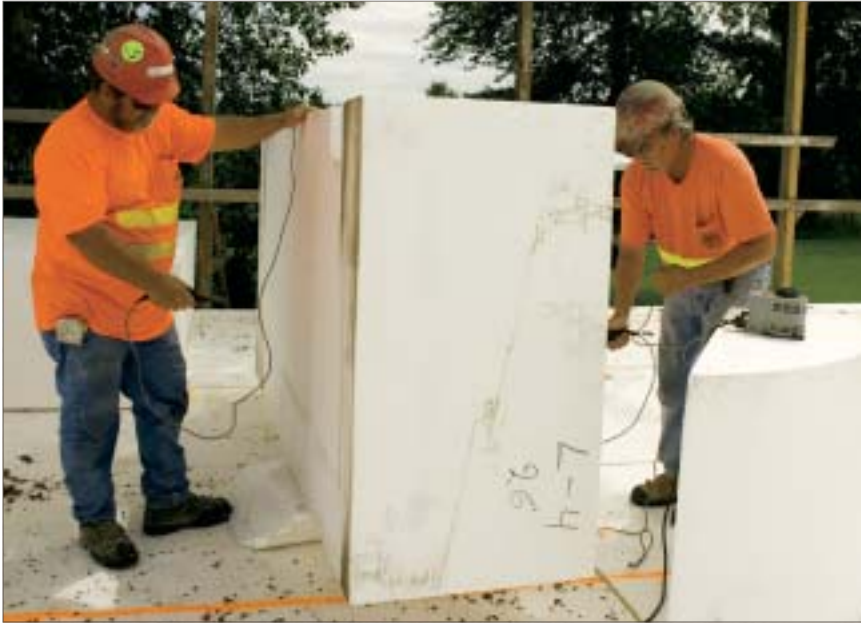
Geofoam was cut by two men using an electrically heated wire about five ft long.
Photo by John Livzey.

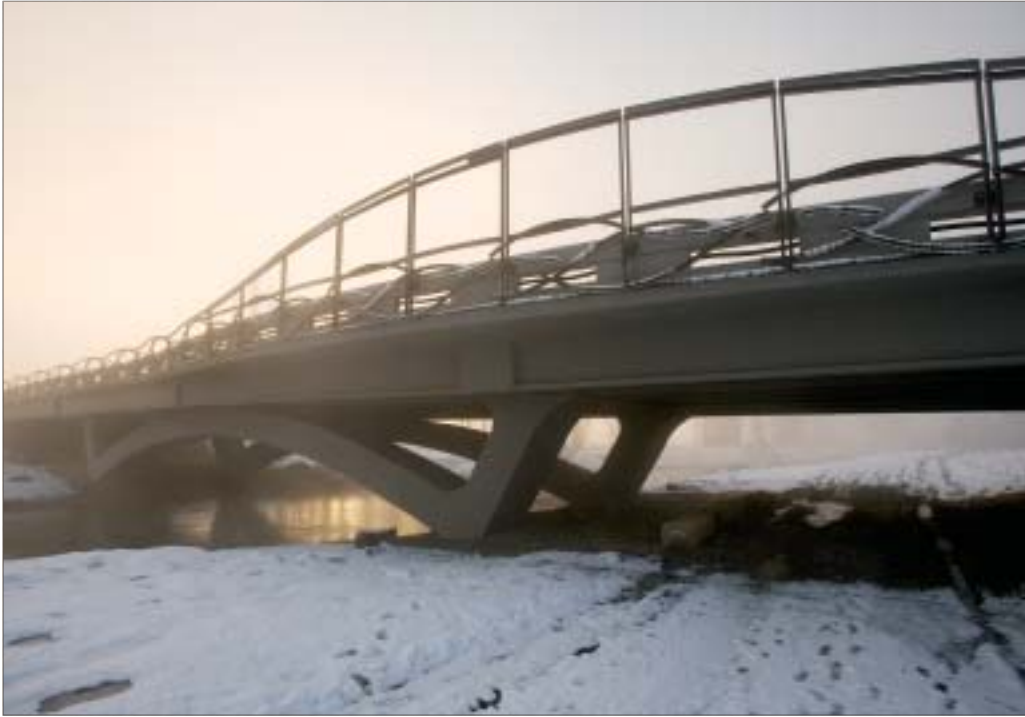
Clear separation of the trail running below from the bridge itself makes recreational activities safer for pedestrians, skaters, and bicyclists. Photo by John Livzey.
