Wolf Creek Dam Repair

Monitoring seepage in an earthen dam.

By William Walker and
Jim Hummert, Jr.

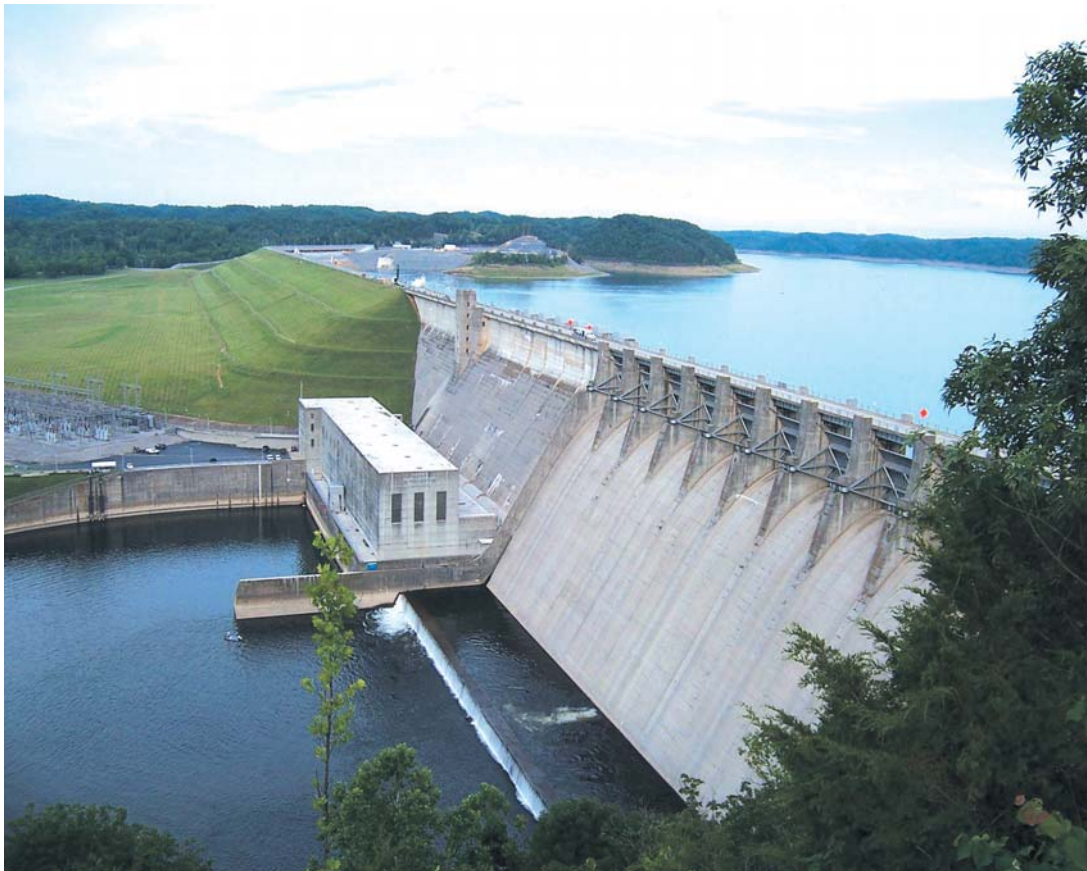
The Wolf Creek Dam near Jamestown, KY, is monitored with an automated data acquisition system (ADAS). The ADAS monitors the large number of piezometers measuring water level (seepage from the reservoir) in the embankment.

The ADAS monitors the large number of piezometers measuring water level (seepage from the reservoir) in the embankment. System installation began during the summer 2008. All instrument readings are collected by a host PC located in the dam's powerhouse. A local FTP server provides remote transfer of daily data files to both the Corps' Nashville district office and the URS St. Louis office, where data are being managed in the USACE WinIDP program. In addition, URS is hosting a project web server that displays graphs and instrument read-

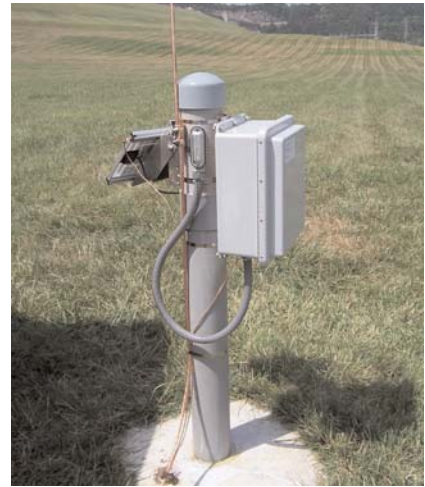
The ADAS consists of 81 vibrating-wire pressure transducers being read by Campbell Scientific CR1000 dataloggers and 25 AVW206 wireless interface units.

The ADAS consists of 81 vibrating-wire pressure transducers being read by Campbell Scientific (www.campbellsci.com) CR1000 dataloggers and 25 AVW206 wireless interface units. The AVW206 uses Campbell's spectral-analysis method to eliminate almost all noise from the vibrating-wire signals.
