# Horizontal Drilling Project Replaces Park Water Line

The completion of the longest horizontal drilling project of its kind will assure the water supply for Mesa Verde National Park, one of the country's most-visited historic resources.

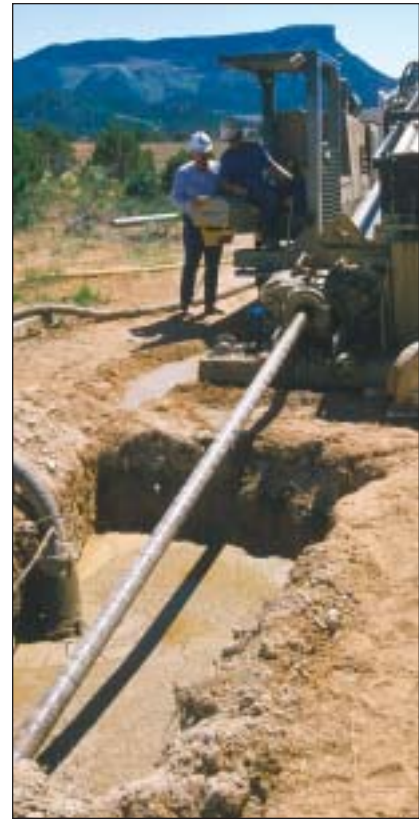
***Drilling crews found that their greatest obstacles lay below ground, where each drill was its own expedition.***

For drilling crews, the greatest obstacle was dealing with what lay below the ground—where varying substrata of rock, shale, sandstone, clay, and cobble turned each drilling attempt into its own underground expedition. The drilling crews learned quickly what they were up against when one of the first lengths of pipe installed jammed as it was being pulled back through the bore. The protocol for the drilling crews called for working uphill whenever possible, bringing the drilling mud and bentonite reclaiming solution back to a collection pit. Rigs (Vermeer Manufacturing Company, [www.vermeer.com](http://www.vermeer.com)) were fit-

ted with 15- and 18-ft drilling clips, and each bore was opened with a 4-in. diameter hole that was back-reamed and then redrilled to widen its dimension.

Lengths of pipe were installed by hooking on to them from the drilling site and pulling them back through the hole. But crews quickly learned the hole that had been drilled could easily be disturbed, with clay soils absorbing fluid from the drilling operation and expanding, or cobbles collapsing and blocking the passage. After excavation to clear the first jam, crews readjusted their expectations of the clearance required for free passage of each length of newly installed pipe and were able to avoid another blocked installation attempt for the rest of the project.
