It's in There

Epoxy overlay system for bridges utilizes unique aggregate that stores anti-icing chemicals.

By Russ Alger and
Joel Kunnari

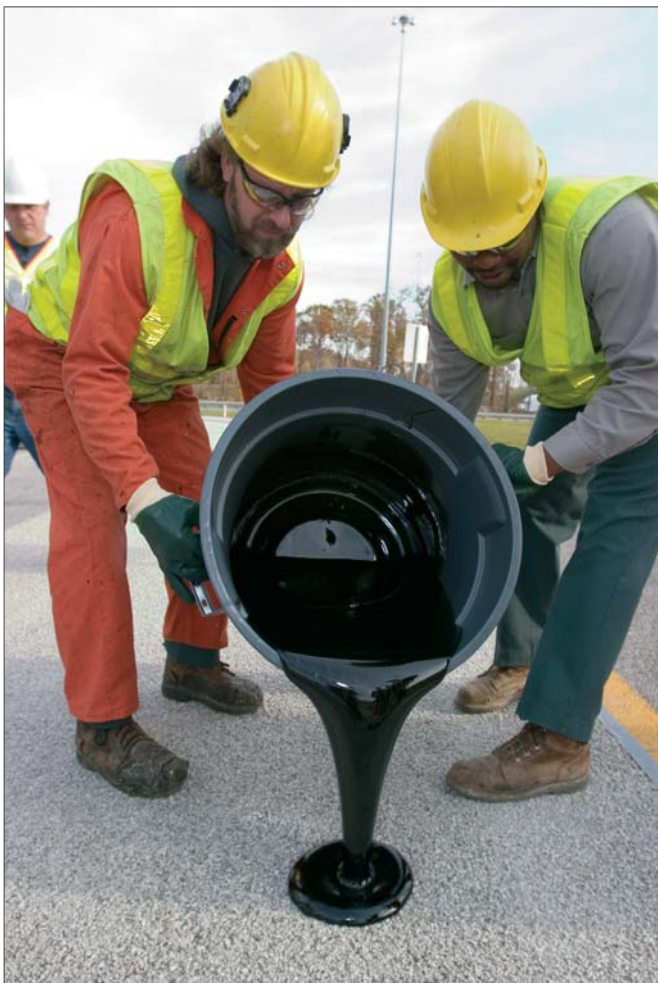
The surface overlay system consisted of an epoxy...

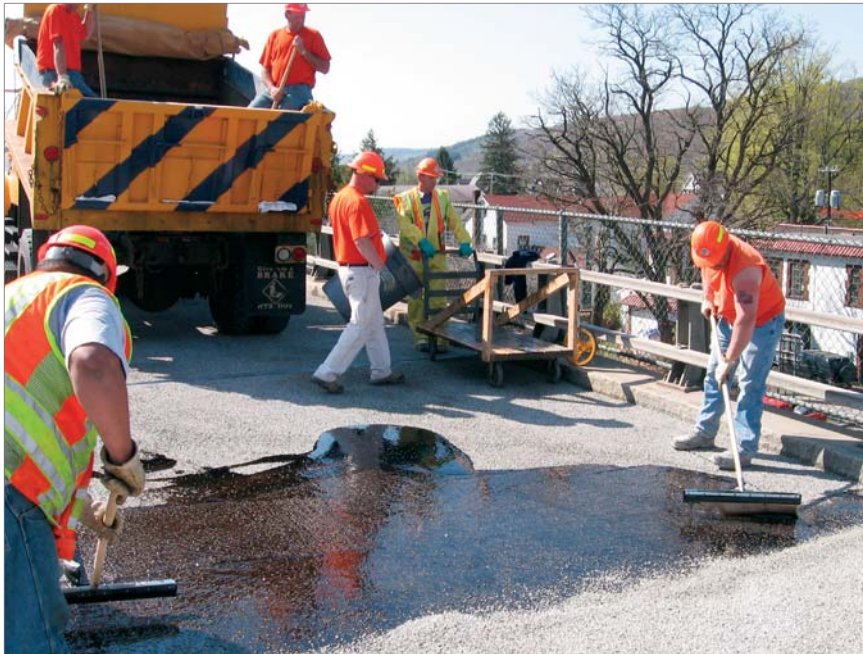
...that was squeezed into place...

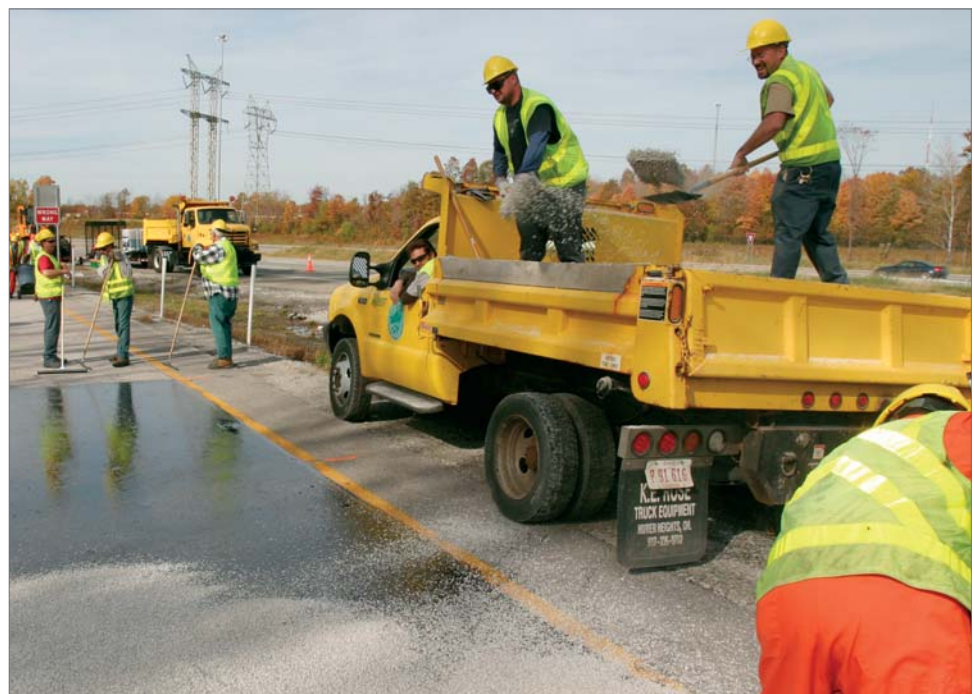
...and then covered with stone...

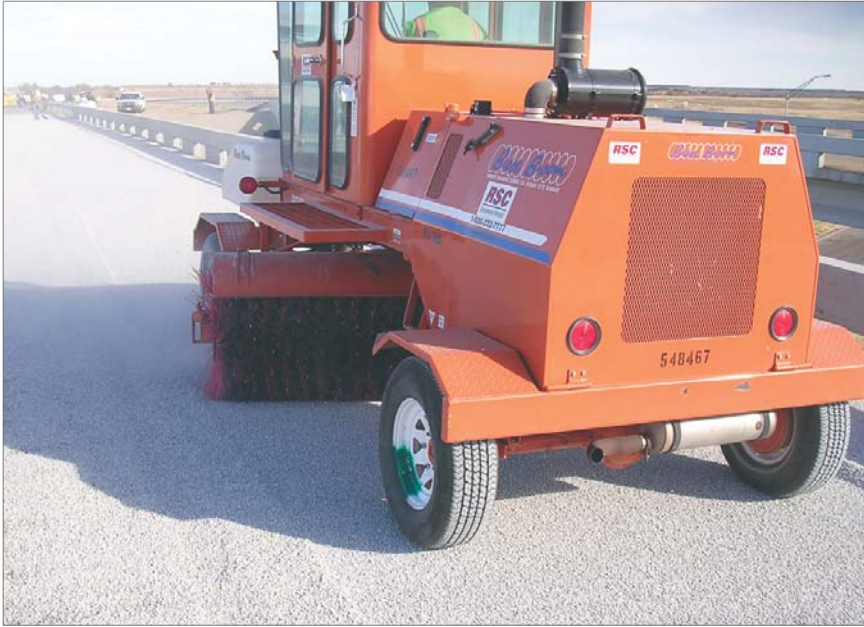
...after which excess aggregate was removed by sweeping.
