Air Station Launches Defense Against Fine Grit

Sugar sand removal from a wastewater stream.

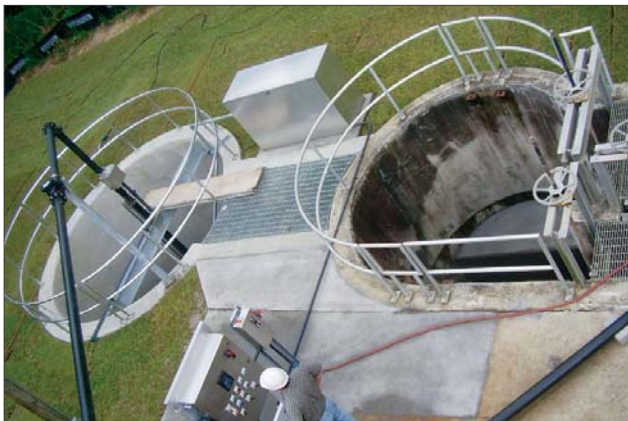
The grit removal system is comprised of the Grit King unit and a grit washer/classification unit. Valving, grit classifiers, grit pumps, dewatering decanters, and control systems are available to provide a comprehensive grit removal package.

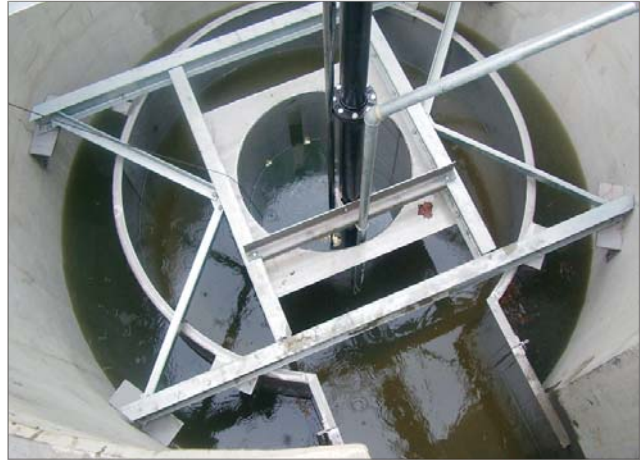
This hydrodynamic vortex separator removes fine sand from the wastewater flow at the Marine Corps Air Station in Cherry Point, NC.

Ultimately, the team chose to implement as its grit removal device a Grit King® hydrodynamic vortex separator supplied by Hydro International Inc. (www.hydro-international.biz). Pete Duty & Associates of Durham, NC, acted as the local sales agent.

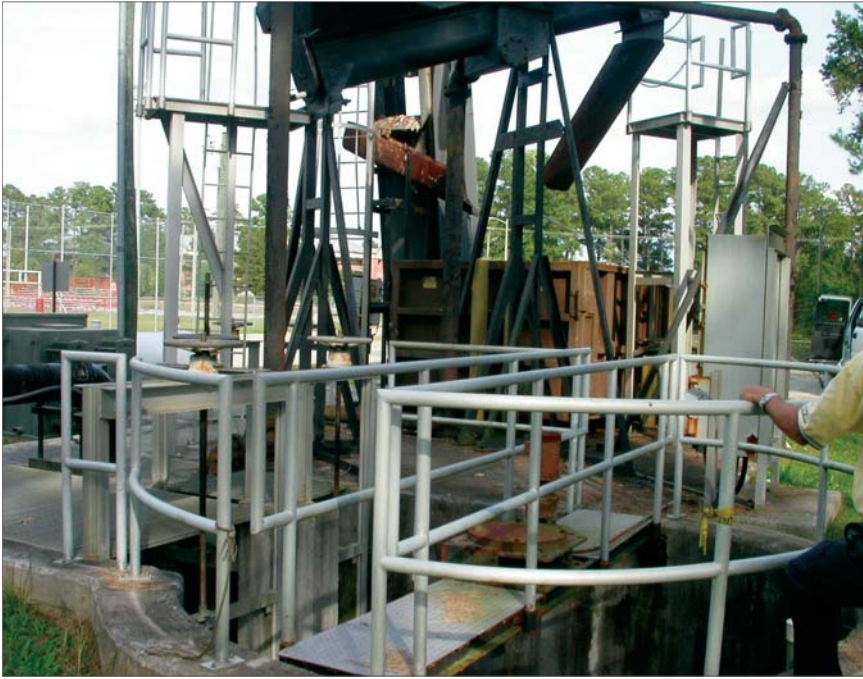
The contractor was able to use the empty chamber of the former grit removal system once all the components had been removed.

Once the new concrete cylinder was installed, it was tied into the existing flow channel system. The internal components had been removed from the former paddle wheel-type grit removal system, which allowed the contractor to use the empty chamber as flow channel.

The contractor poured concrete into the chamber to create a weir wall to separate the chamber into a front half and a back half. The weir wall would divert wastewater flows entering the front half of the chamber to the separator inlet pipe. The degrittled overflow (outlet) from the separator was returned to the back half of the chamber, where it would flow out of the chamber to the pumps at Pump Station 4259. In all, the concrete work took about five months to complete.
